Sample Building And Timber Pest Report

Parkway Inspections

5 Cornwall Avenue , Turramurra, NSW, 2074

Pest And Building Inspection

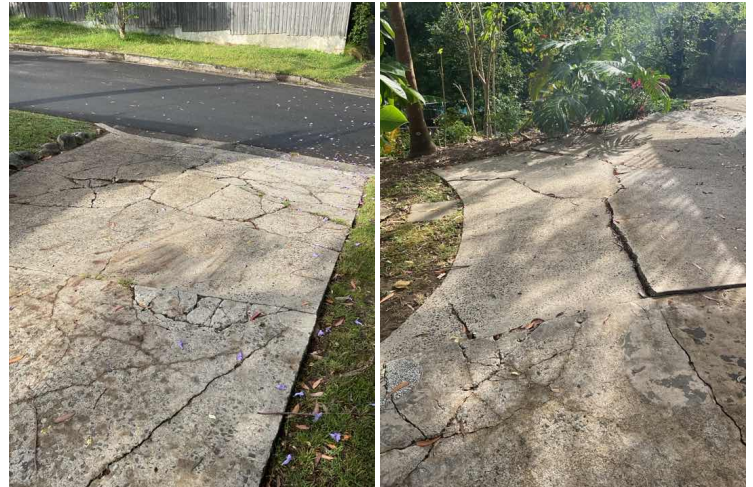
Common cracks were observed on the driveway. Whilst these cracks appeared to be typical at the time of inspection, we strongly recommend you monitor these cracks and if worsening occurs contact a concreter for further advice.

Surface raised and settled in some areas. This can cause water ponding. Relaying recommended.

Driveway has visible tripping hazards. Repairs are required by a qualified concreter to avoid potential injury.

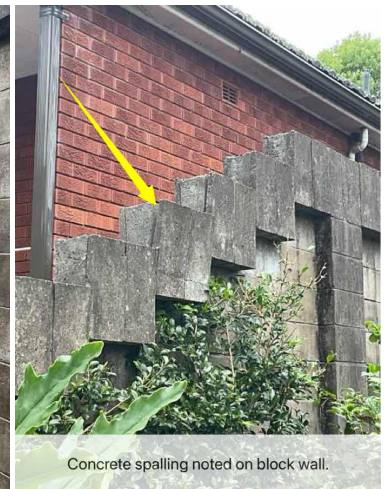
Concrete blocks have begun to break away from the solid concrete fill.

Concrete spalling noted on block wall.

On inspection, defects were present that will require further accessing and recommendations by licensed and qualified trades persons.

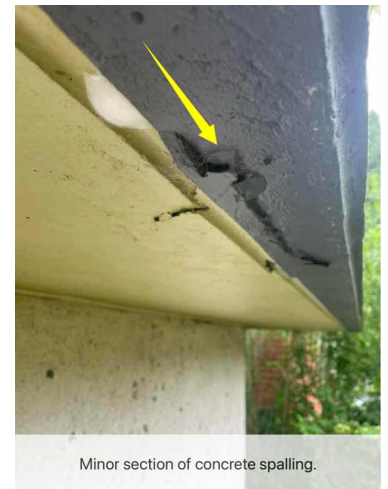
Minor section of concrete spalling.

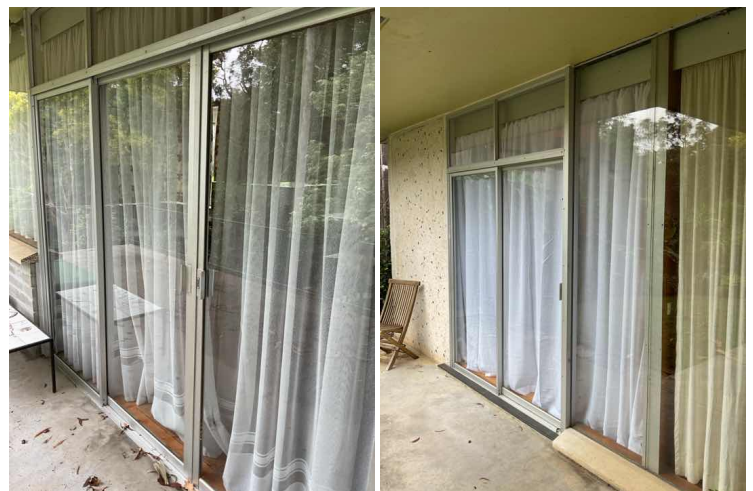
On visual inspection, the general condition of the windows is serviceable for the age.
Cracked window pane. A qualified glazier should be engaged to repair.
Deterioration of sections of window putty was observed.
A qualified glazier should be engaged for repairs.

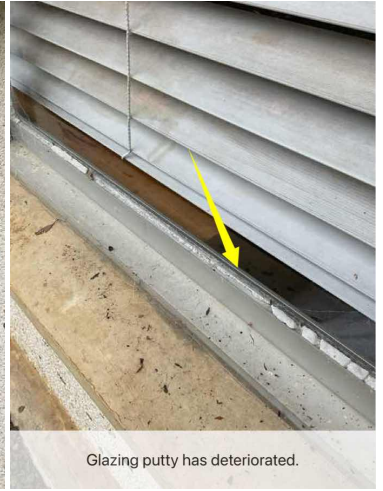
Glazing putty has deteriorated.

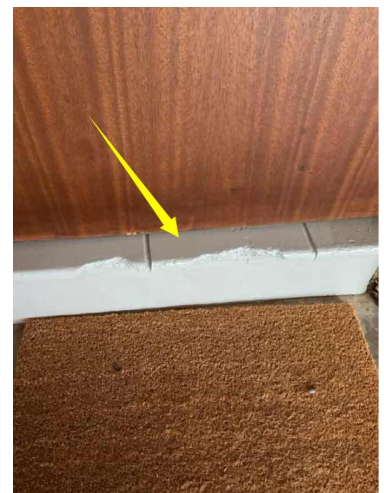
Damage to the bullnose tiles at internal entry.

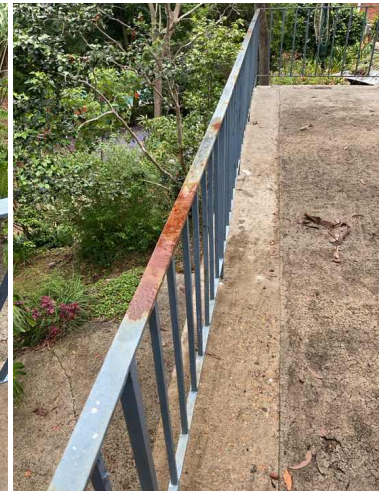
Corrosion noted to the balustrades, we recommend repairing these so as to preserve the integrity of the balustrade.

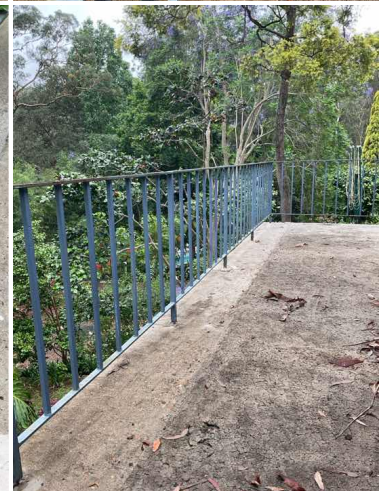
Concrete spalling and erosion to metal balustrade.

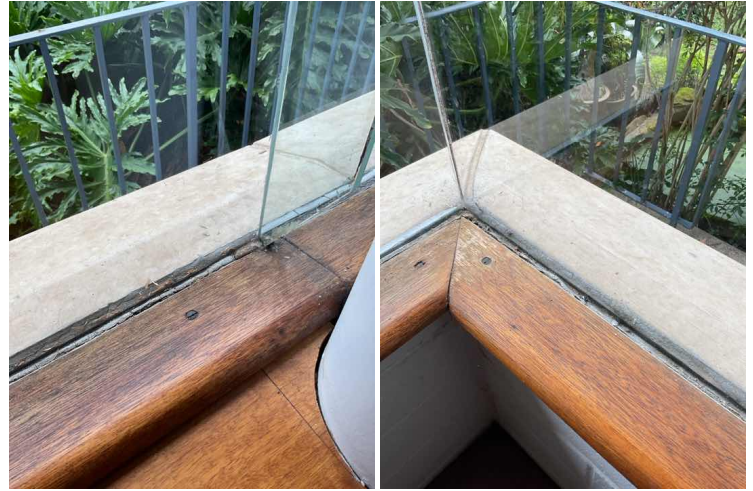
General age wear deterioration - The window frame/ components showed evidence of ageing and wear. General maintenance works required.

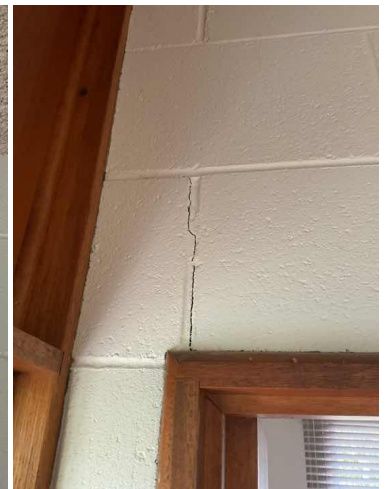
Blockwork cracks noted. These are typical and generally patch and paint will suffice, however we recommend you monitor these cracks and if they become wider or longer you will need to contact a structural engineer to assess.

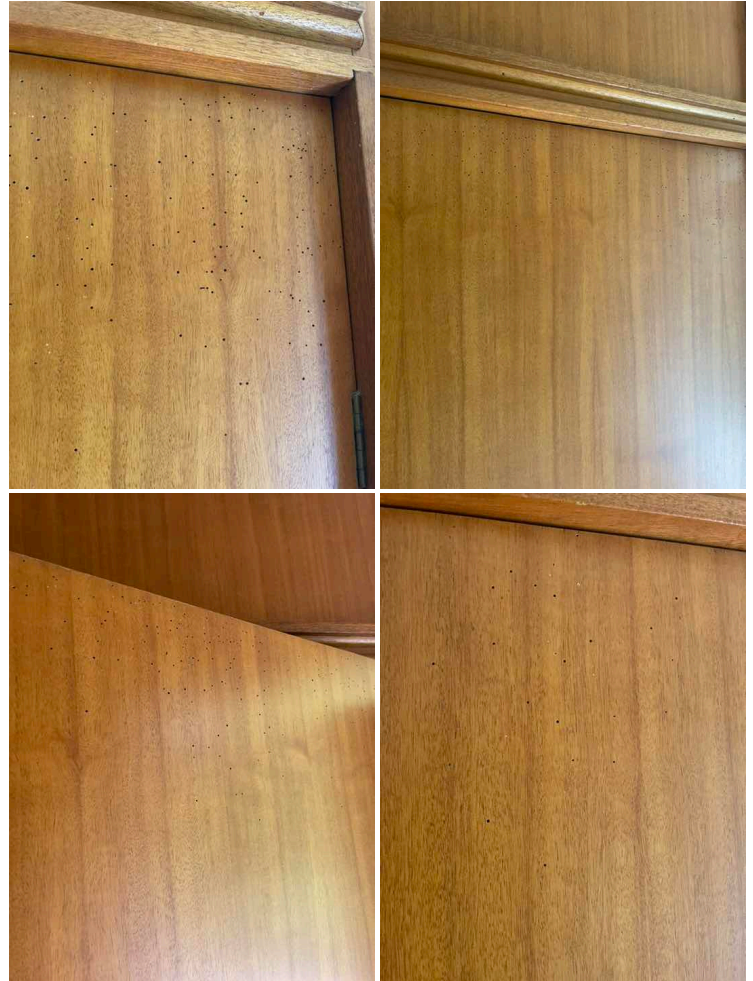
Old timber Borer damage noted on built-in wardrobe doors.

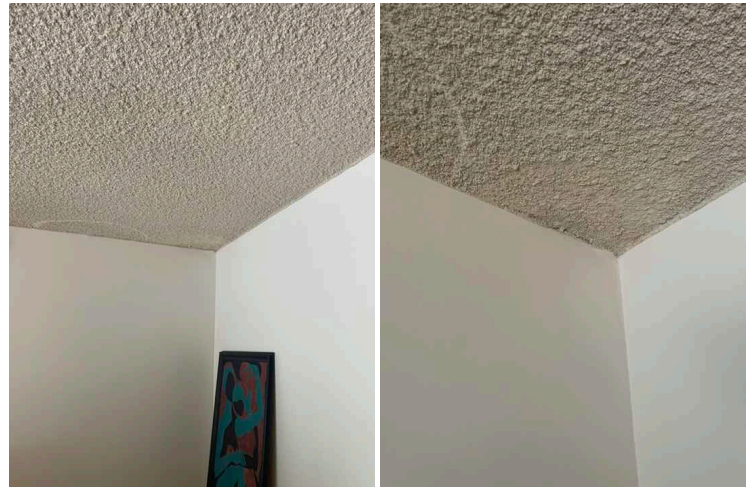
Ceiling stains - No moisture readings obtained. These may have been repaired however you will need to monitor after a prolonged period of rainfall. If leaking persists, a qualified plumber should be engaged for repairs.

This water stain is adjacent to the external down pipe for the roof. An old leak that seems to have been rectified.

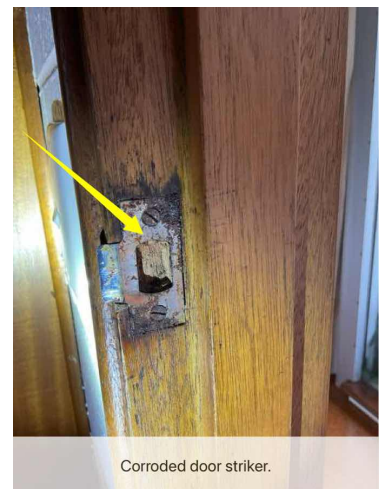
Striker plate/Keeper is loose/damaged. Replace and adjust.

Corroded door striker.

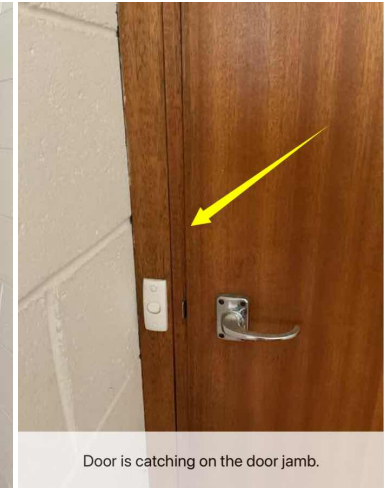
Uneven / out of square door causing binding. A qualified carpenter should be engaged to refit.

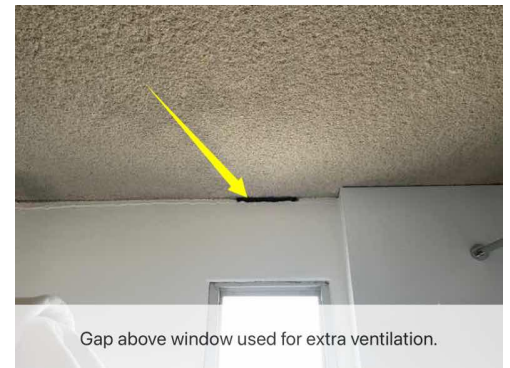
Gap in wall intended for extra ventilation.

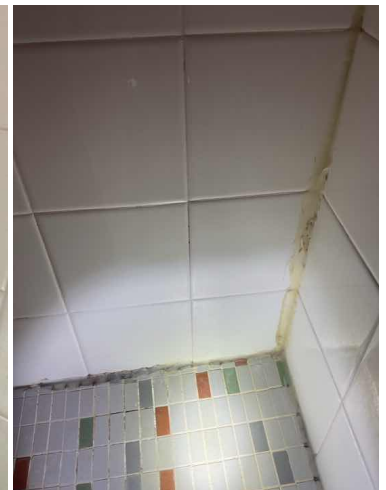
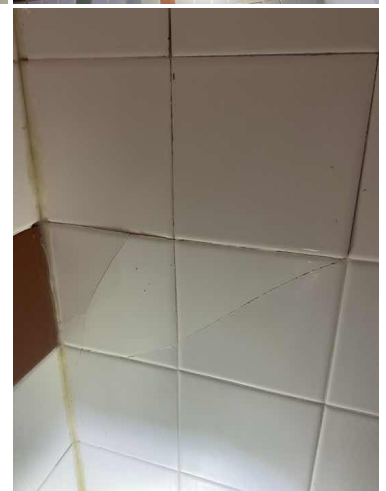
Tile grout deterioration to tiles to the shower area. Re-grout / seal. A qualified tiler should be engaged for recommendations and repairs, as water may seep in creating conducive conditions for termites.

Cracked tile/s noted. With water leaking through the cracks, water may seep in creating conducive conditions for termites. A qualified Tiler should be engaged for advice and recommendations.

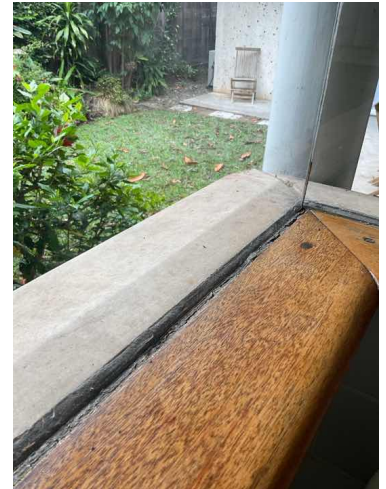
General age deterioration - The window frame/components showed evidence of ageing and wear. Recommendations: General maintenance works required.

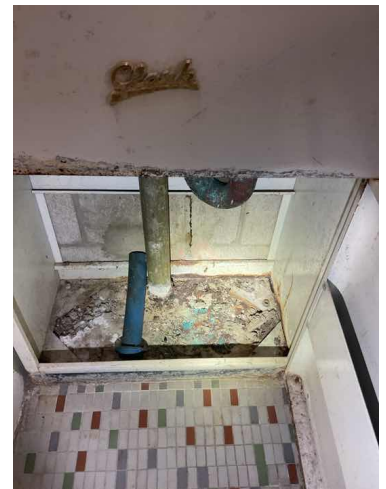
Tub is corroded. Replacement recommended.

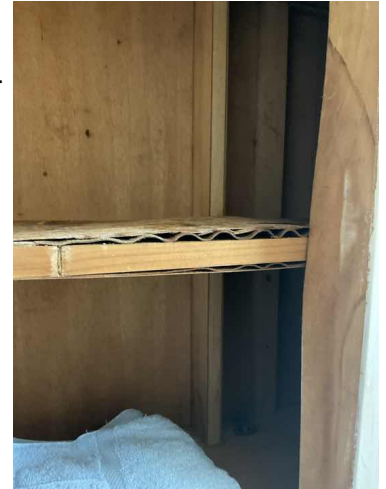
Water damage to cabinet observed. Replacement required. Contact a cabinet maker for repairs.

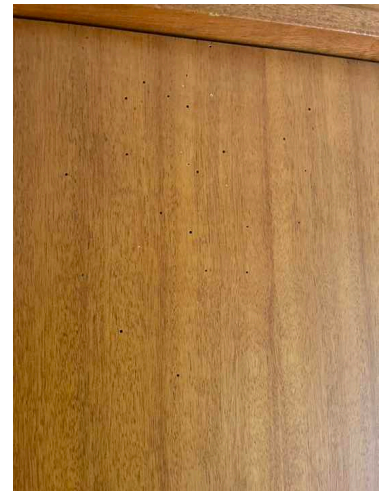
Yes, an undetermined species of borer damage was found.

If any evidence or damage has been reported then you must have a building expert determine the full extent of damage and the estimated cost of repairs or timber replacement (see terms & limitations). Borer activity is usually determined by the presence of exit holes and/or frass. Since a delay exists between the time of initial infestation and the appearance of these signs, it is possible that some borer activity may exist that is not discernible at the time of inspection.
