Sample Building And Timber Pest Report

Parkway Inspections

14 The Walk, Murrays Beach, NSW, 2281

Pest And Building Inspection

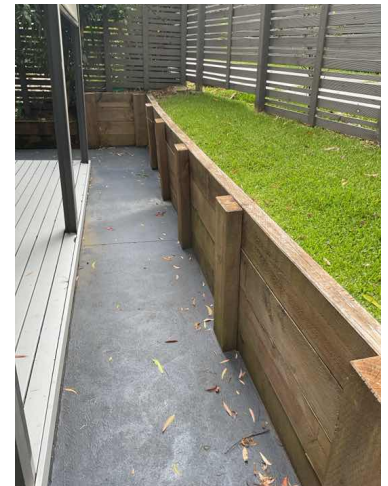
Slight lean noted on wall.

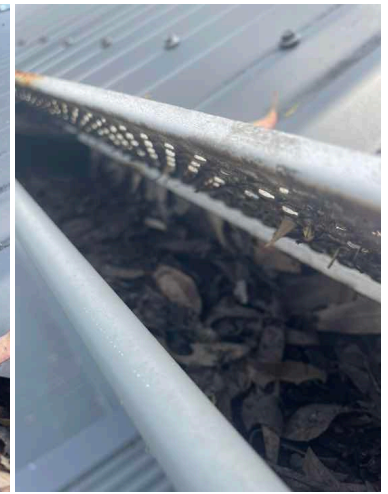
Debris in guttering areas- this requires cleaning out to prevent blocking of downpipes and leaking into eaves and fascia. Have gutters cleaned and assessed by a plumber for adequate fall. Regularly clean to prevent ponding. Ponding water will contribute to rust.

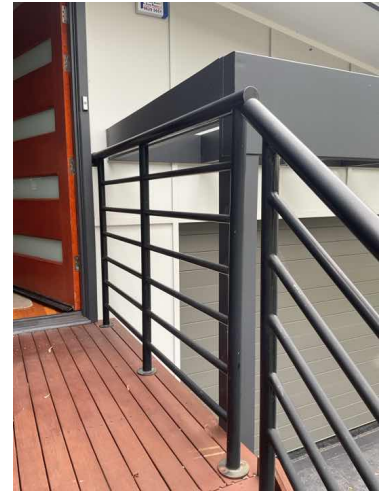
Slight wobble to handrail, screws need tightening.

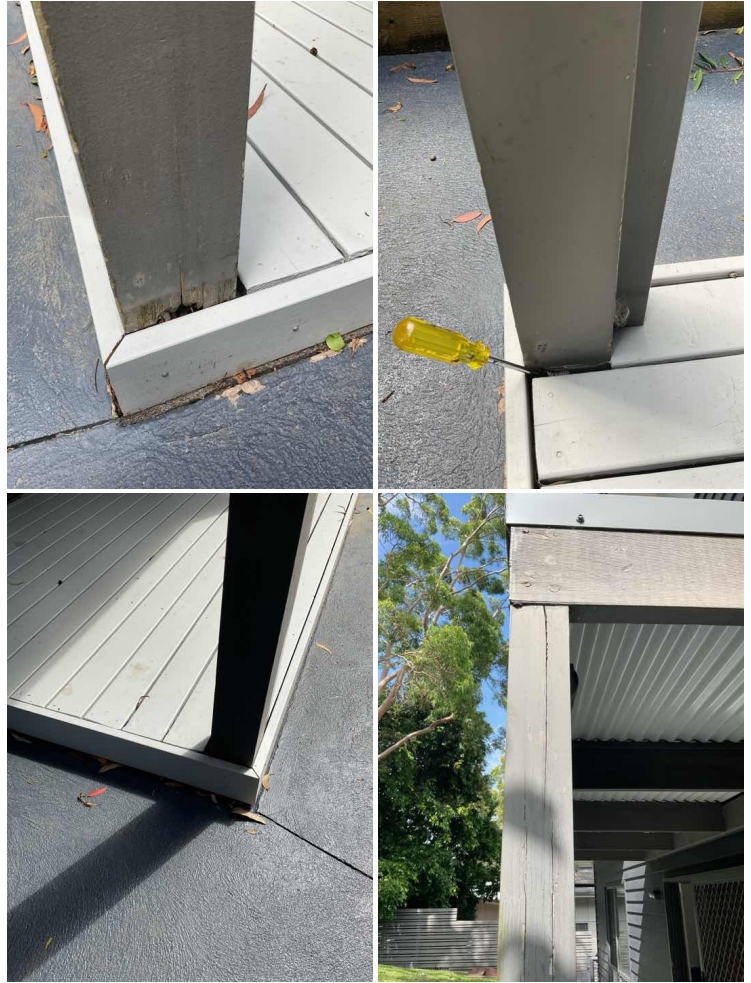
Timber fungal decay in section of bearers or joists. This is a safety hazard and repair is required. A qualified carpenter should be engaged to replace all affected timbers.

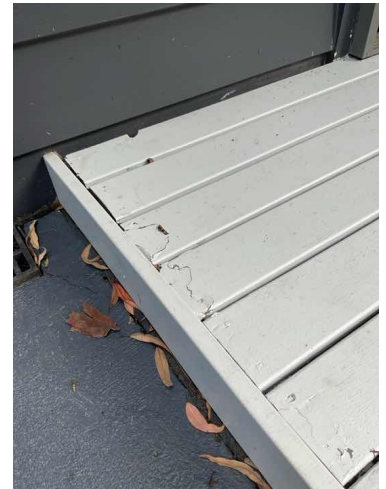
Moisture damage was observed on deck boards - Recommendations: Evaluation and repairs by a qualified decking contractor.

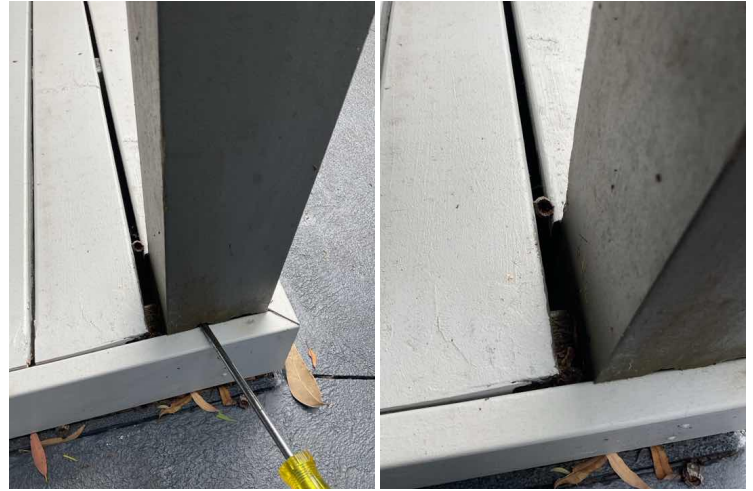
Post base timber fungal decay. Repairs as required. It is preferable to have posts on stirrups kept out of contact with soil. Timber in contact with ground is conducive to termite infestation and timber fungal decay.

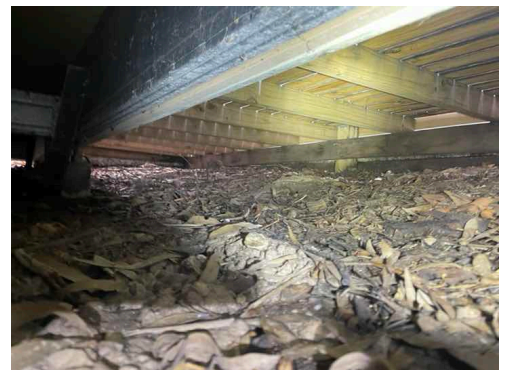
Timber decay evident. Underside of decking.

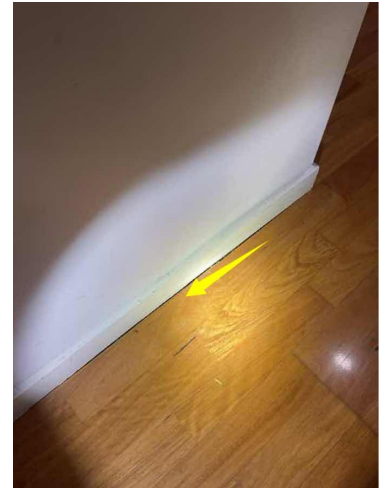
Timber flooring not finished under skirting boards, small gap noted.

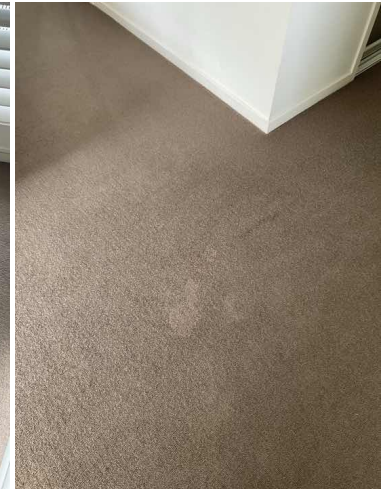
Stains observed - Steam cleaning may rectify stained areas but they appear entrenched.
Carpet appears dilapidated and may re-stretching.
Check with a qualified carpet layer if this is feasible.

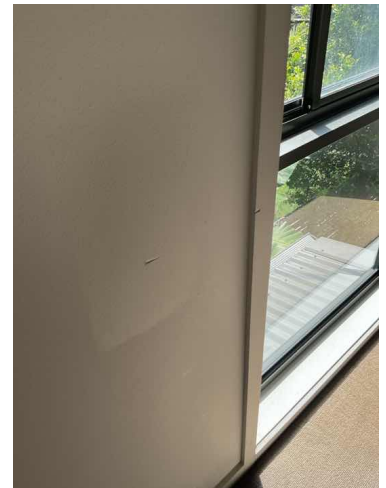
Impact damage noted. Contact a qualified painter for repairs.

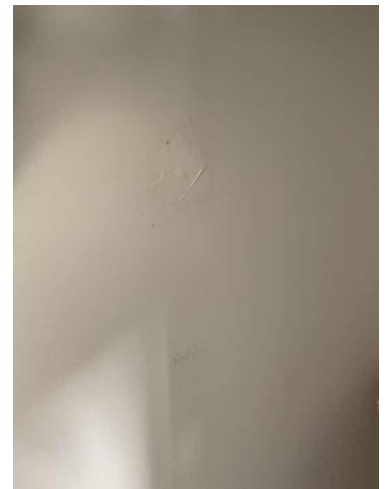
Settlement Cracks Noted. These are typical and generally patch and paint will suffice, however we recommend monitor these cracks and if become wider or longer, you will need to contact a structural engineers to assess. Incomplete Patch/Paint repairs noted. I recommend you contact a qualified painter for repairs.

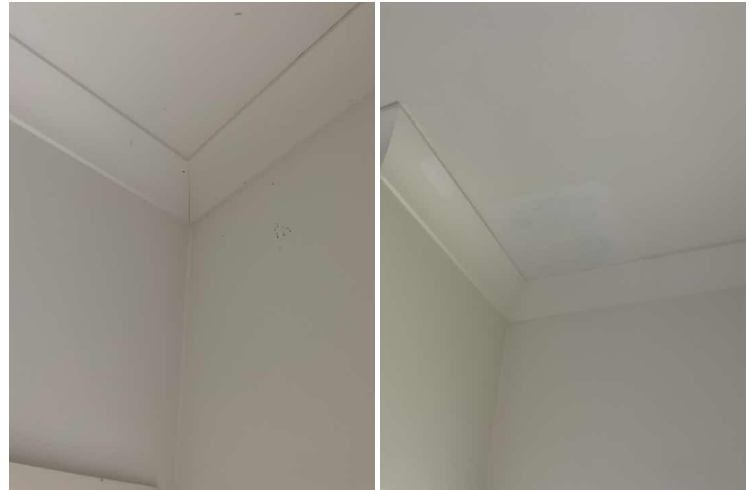
Typical cornice separation/detachment observed. I recommend you contact a qualified painter for repairs. Incomplete patch/paint repairs noted. I recommend you contact a qualified painter for repairs.

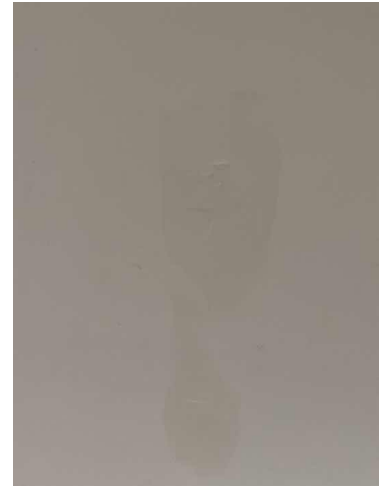
General ageing and/or denting and the like is evident on wall linings -
Recommendations: A qualified painter should be engaged to assess and repair as required.

Incomplete Patch/Paint repairs noted. I recommend you contact a qualified painter for repairs.

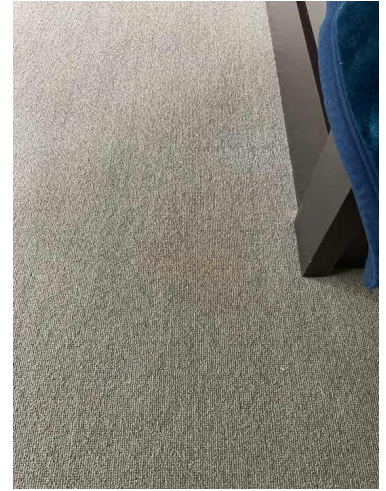
Stains observed - Steam cleaning may rectify stained areas but they appear entrenched.

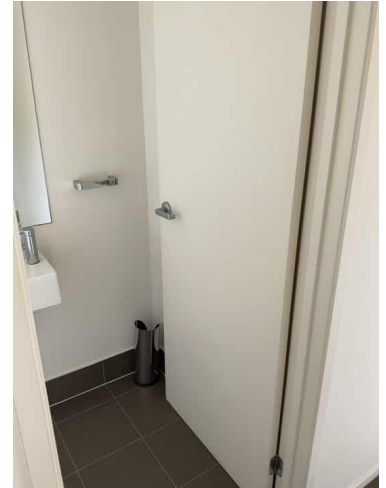
Door stop should be fitted - Wall damage from door handle impacting wall lining has occurred. Recommendations: A qualified carpenter should be engaged for advice and recommendations.

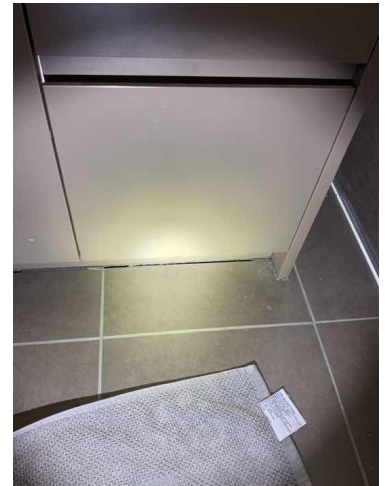
BATHROOM(S)	Bathroom 1	Flooring	Deteriorated grout noted. This should be repaired as this will lead to water ingress under the tiles causing uplifting and possible water penetration.
SUBFLOOR	Sub-Floor Observation.	Dampness	Dampness in sub floor soil. Damp sub floor soil should be avoided as it can cause fungal decay, mould and possibly footings problems. Recommendations: A qualified drainage plumber should be engaged for advice and recommendations.
CONCLUSION	Condition Of Inspected Structure	The Incidence of Minor Defects	The incidence of minor defects in this residential building as compared with similar buildings is considered LOW

Deteriorated grout noted. This should be repaired as this will lead to water ingress under the tiles causing uplifting and possible water penetration.

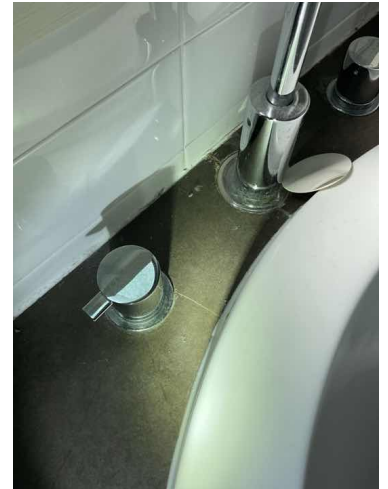
Cracked tile/s noted.

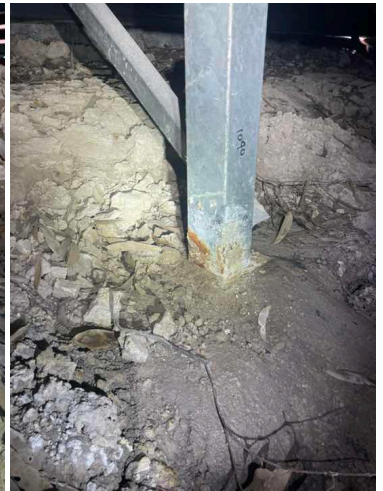
Minor corrosion observed on posts.

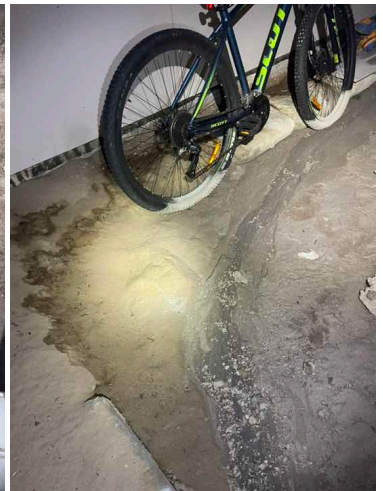
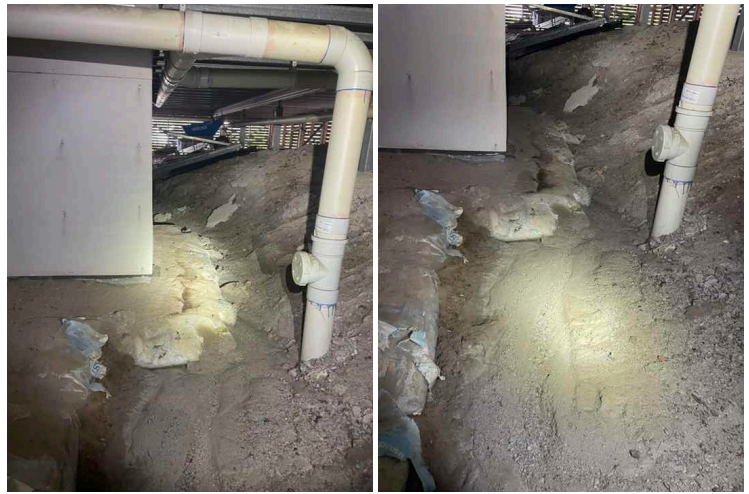
Dampness in sub floor soil. Damp sub floor soil should be avoided as it can cause fungal decay, mould and possibly footings problems. Recommendations: A qualified drainage plumber should be engaged for advice and recommendations.
