# Sample Report

## Parkway Inspections

**44 Rayner Rd, Whale Beach, NSW, 2107**

### Pest And Building Inspection

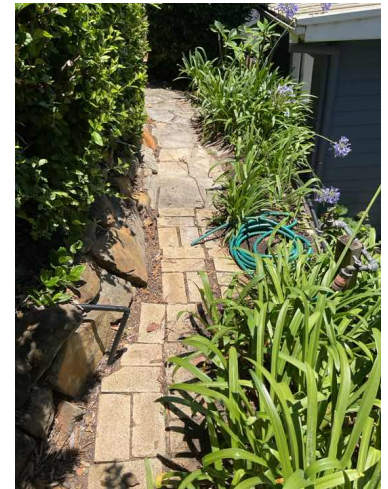
Surface raised and settled in some areas. This can cause water ponding. Relaying recommended.

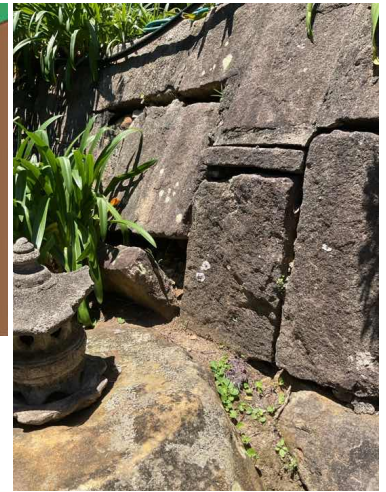
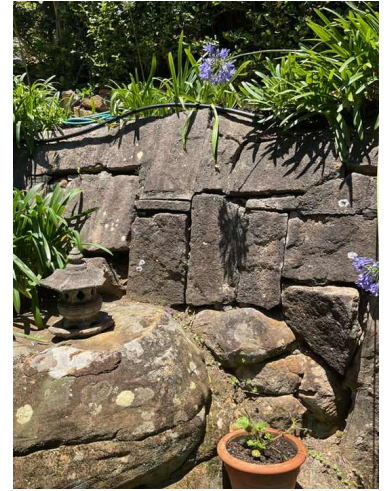
Retaining wall cracking. Normally this occurs if adequate drainage has not been provided (Ag Line) or a poor footing system or a combination of reasons. A qualified brick layer should be engaged for advice and recommendations.

Retaining wall leaning due to deterioration and age. A qualified brick layer should be engaged for advice and recommendations.

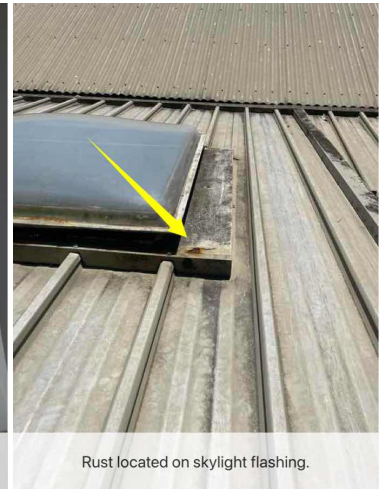
Perspex skylight showing signs of deterioration.  
Possible cracks.

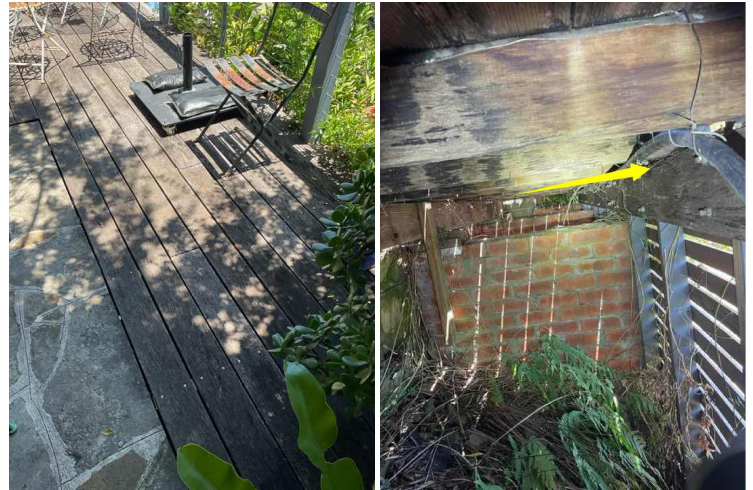
General timber decay in decking components. A qualified carpenter should be engaged for advice and recommendations.

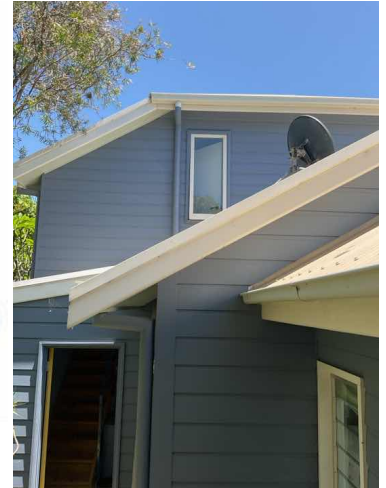
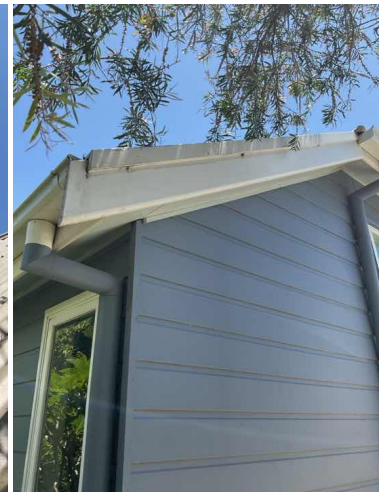
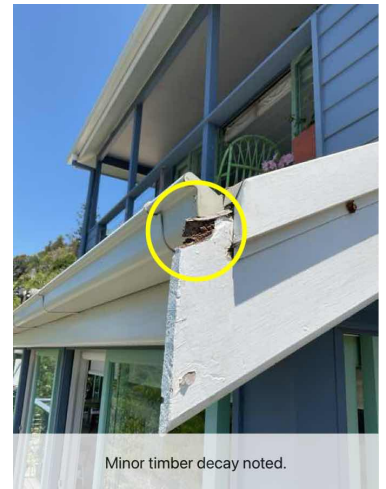
On visual inspection, the general condition of the fascia/barge boards is serviceable. Paint / finish was deteriorated in areas and is in need of maintenance - Sanding back affected areas and painting required. Timber fungal decay (rot) visible. Recommendations: A qualified carpenter should be engaged to replace all affected timbers.

Minor timber decay noted.

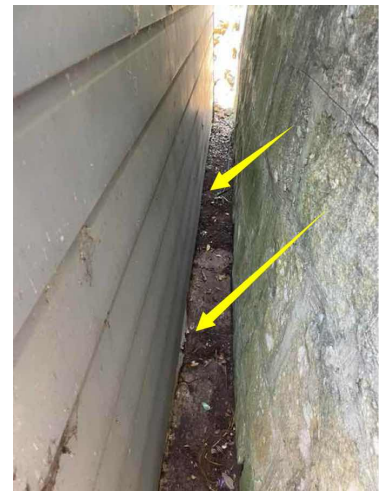
Vents are covered by soil/vegetation or have debris restricting ventilation to the sub floor Recommendations: Remove vegetation and or lower soil levels so that sub floor vents are unobstructed and allowing free flowing air.

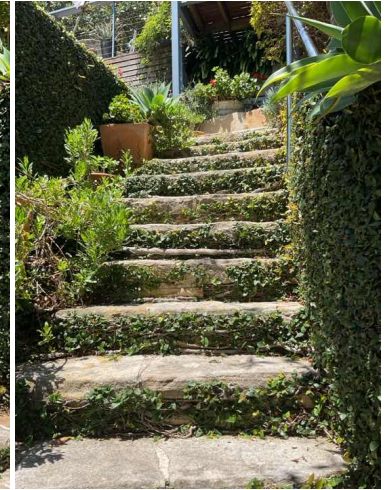
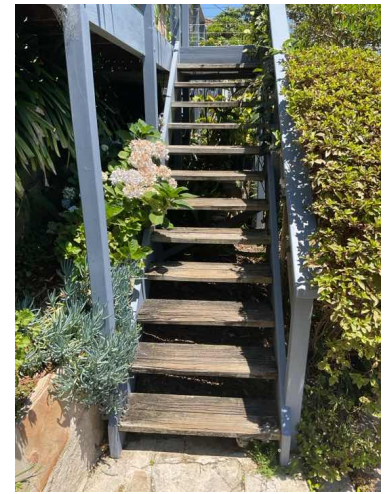
Timber fungal decay in sections. This is a safety hazard and repair is required - Recommendations: A qualified carpenter should be engaged for advice and recommendations.

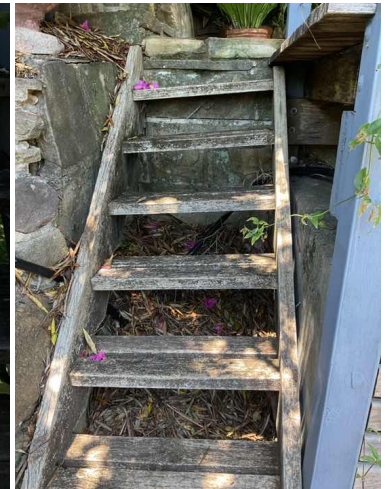
Timber fungal decay in sections of stair treads. This is a safety hazard and repair is required. A qualified carpenter should be engaged for advice and recommendations.

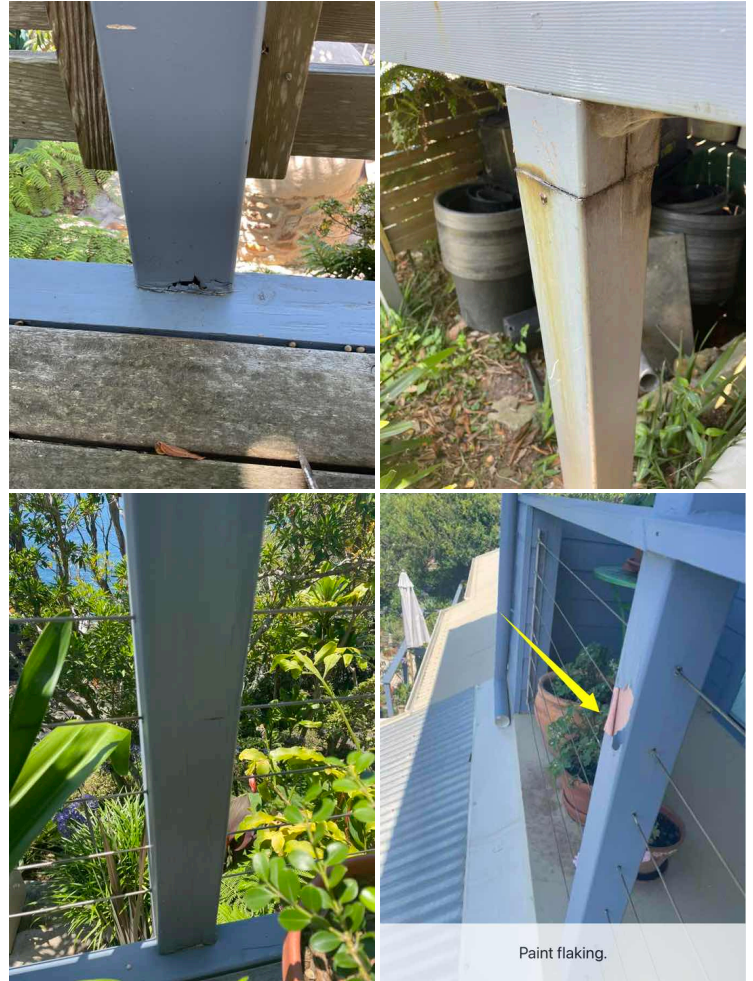
Timber decay evident on rails / balustrade. A qualified carpenter should be engaged for advice and recommendations.

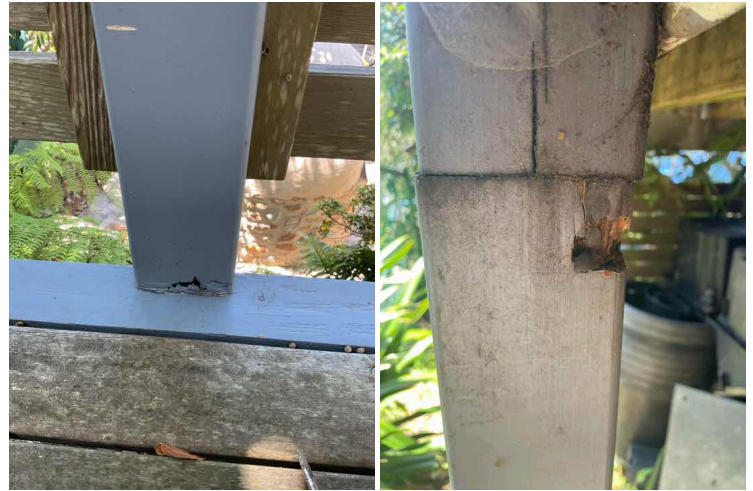
Moisture damage was observed. Recommendations: Recommend evaluation and repairs by a qualified contractor/carpenter.

Minor post base timber fungal decay - Repairs as required. It is preferable to have posts on stirrups kept out of contact with soil. Timber in contact with ground is conducive to termite infestation and timber fungal decay.

Timber decay evident on rails / balustrade -  
Recommendations: A qualified carpenter should be engaged to replace all affected timbers prior to a decision to purchase.

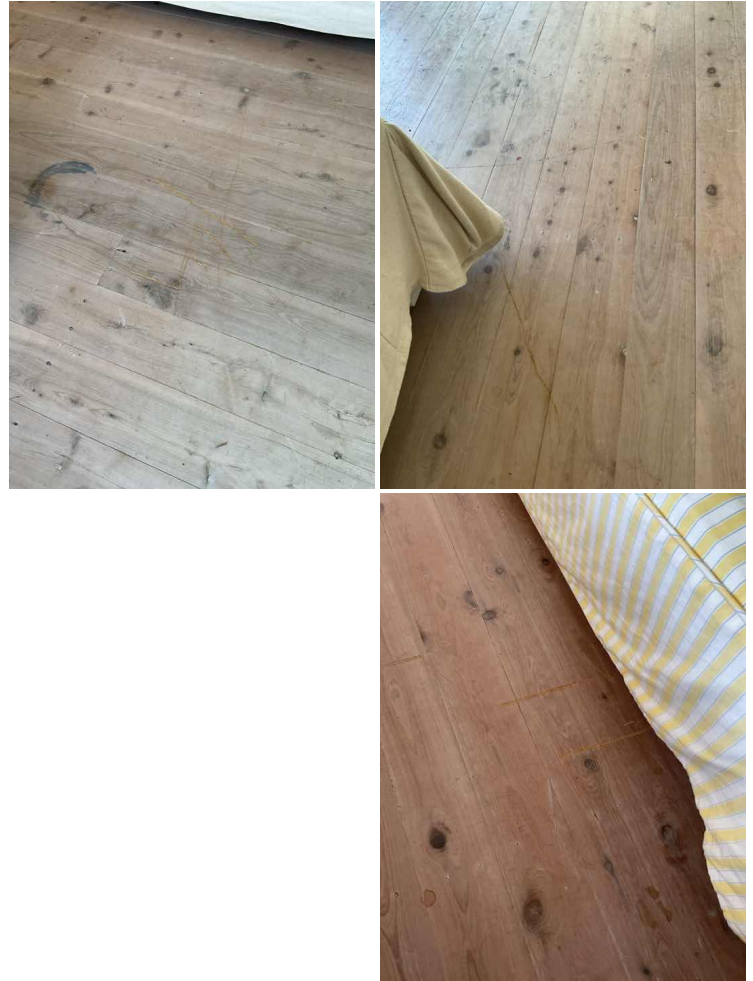
Minor scratches noted on the timber floor.

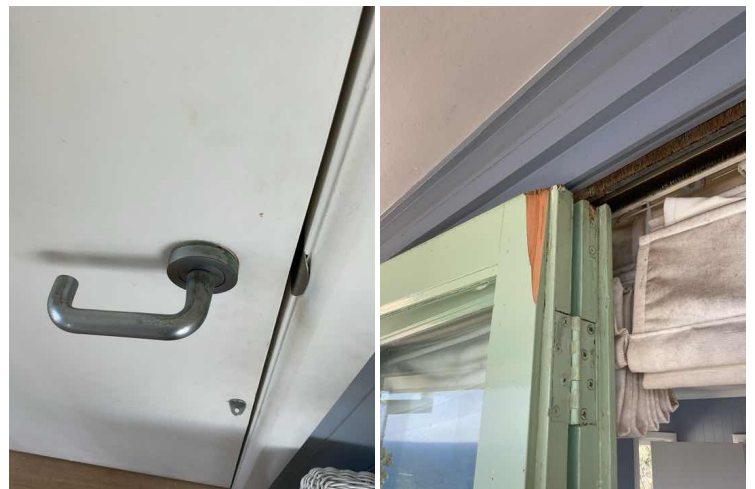
Door lock hardware is loose possibly damaged. Maintenance as required.

Hinge screws missing / loose - Maintenance as required.

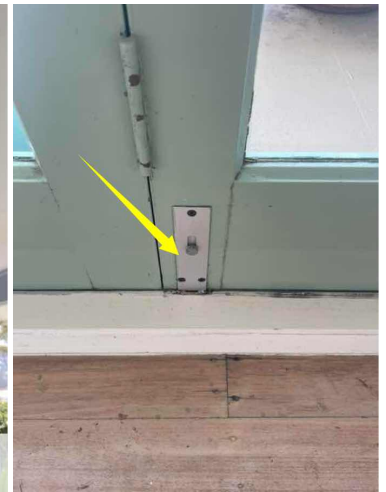
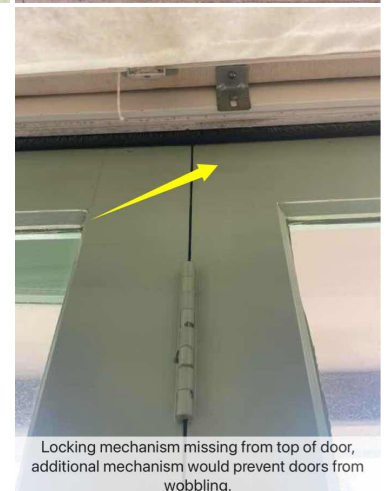
Door hinge broken.

Locking mechanism missing from top of door, additional mechanism would prevent doors from wobbling.

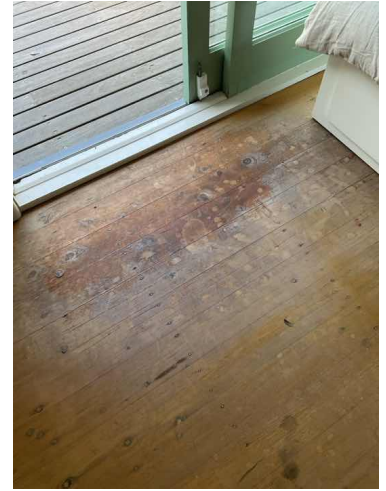
Stained timber flooring - This is normally due some water penetration. This will not be able to be removed and options include replacement, staining all the boards dark or lining same to cover. A qualified carpenter should be engaged for advice and recommendations.

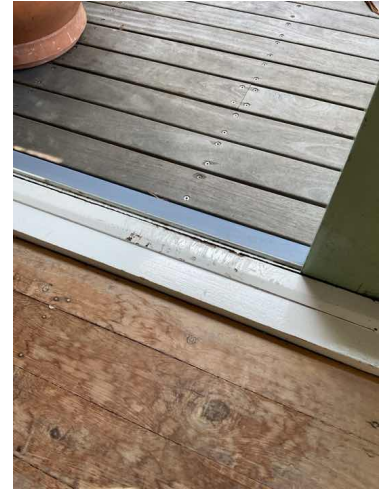
Door / frame deterioration - General age/damage has occurred to door frame, face or components. A qualified carpenter should be engaged for advice and recommendations.

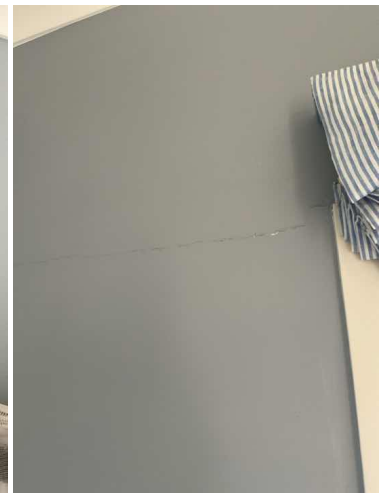
Settlement Cracks Noted. These are typical and generally patch and paint will suffice, however we recommend monitor these cracks and if become wider or longer, you will need to contact a structural engineers to assess.

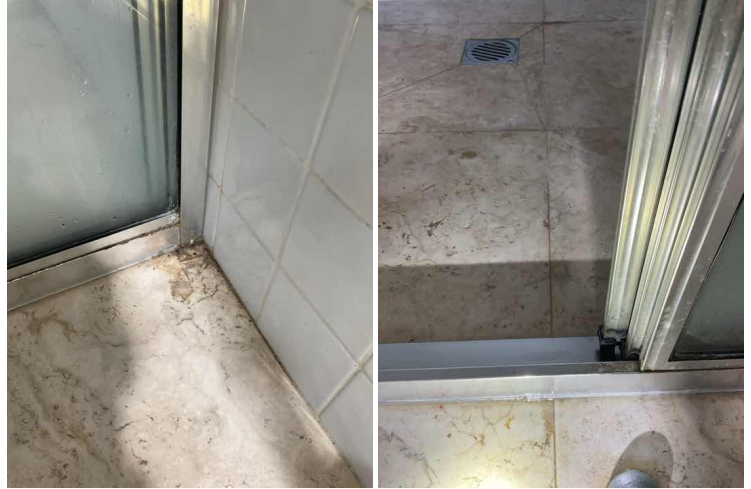
Water is leaking under the shower screen. Engage a suitably qualified tradesperson to assess. Sometimes resealing the shower base to floor will suffice

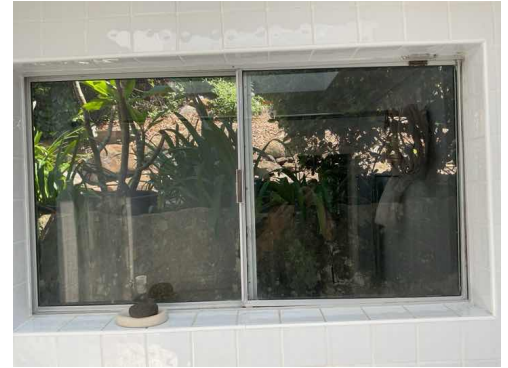
General age wear deterioration - The window frame/components showed evidence of ageing and wear. General maintenance works required.

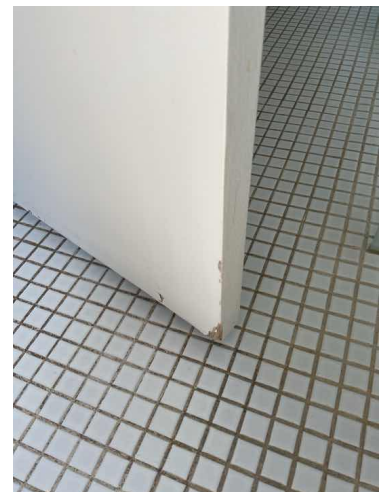
Binding/out of square door frame - This can relate to some differential settlement in the footings, frame movement, age, expansion, shrinkage and the like. A qualified carpenter should be engaged for advice and recommendations.

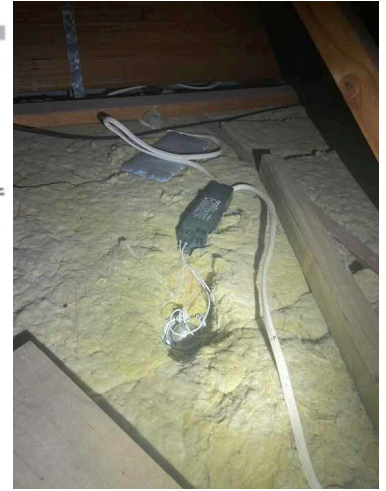
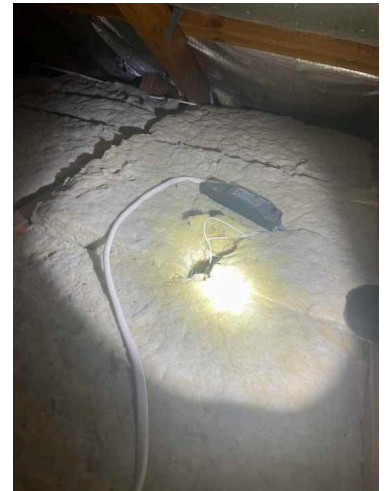
Insufficient spacing between insulation and down lights.

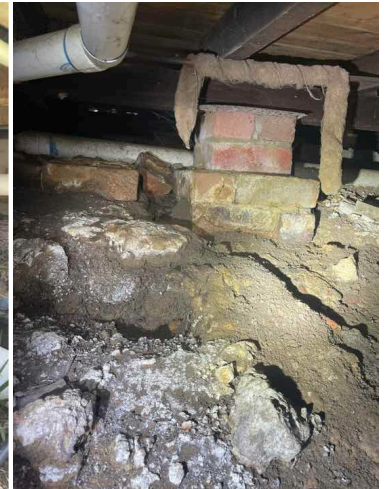
Brick fretting to piers visible. (Bricks breaking to powder form from salts and minerals due to moisture) A qualified brick layer and drainage expert should be engaged for advice and recommendations.

Cracking was evident to the foundation walls. Underpinning may be required to prevent further movement and cracking. We recommend you contact a qualified brick layer and a practicing structural engineer for recommendations and advice.

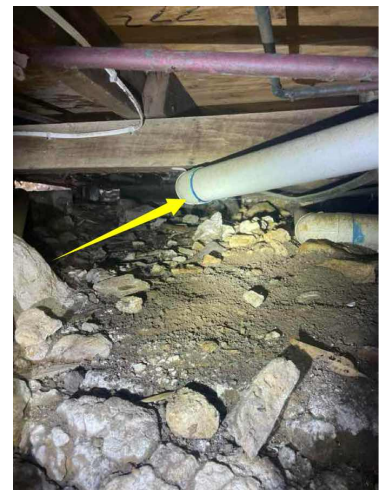
Leaks were noted in the water pipes under the kitchen. This should be repaired by a qualified plumber.

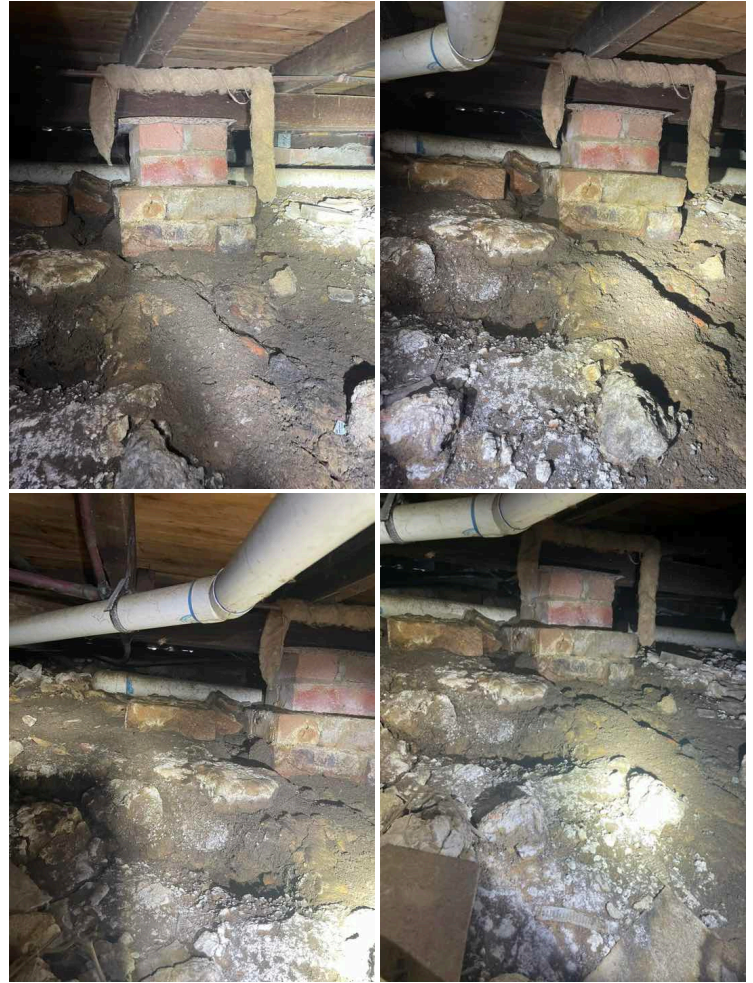
Dampness in sub floor soil. Damp sub floor soil should be avoided as it can cause fungal decay, mould and possibly footings problems. Recommendations: A qualified drainage plumber should be engaged for advice and recommendations.
