Sample Building And Timber Pest Report

Parkway Inspections

56 Cowmeadow Road, Mount Hutton, NSW, 2290

Pest And Building Inspection

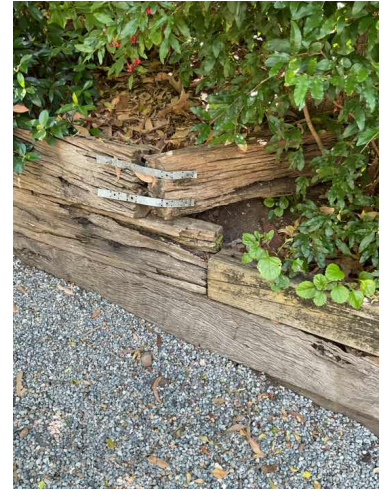
Timber fungal decay evident. Recommendations: A qualified landscaping contractor should be engaged for repairs and recommendations.

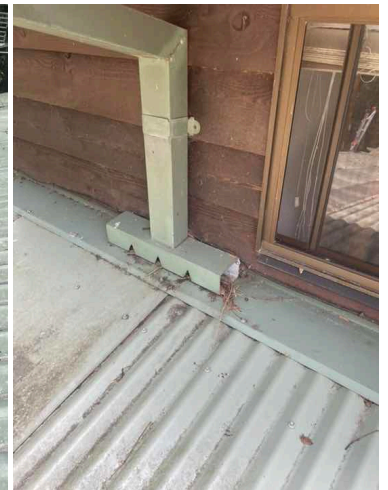
Debris in guttering areas- this requires cleaning out to prevent blocking of downpipes and leaking into eaves and fascia. Have gutters cleaned and assessed by a plumber for adequate fall. Regularly clean to prevent ponding. Ponding water will contribute to rust.

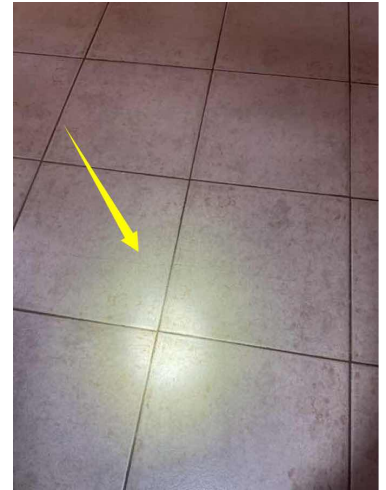
Cracked floor tiles noted. A qualified tiler should be engaged for repairs.

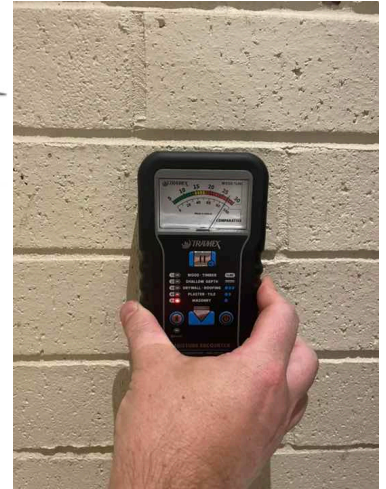
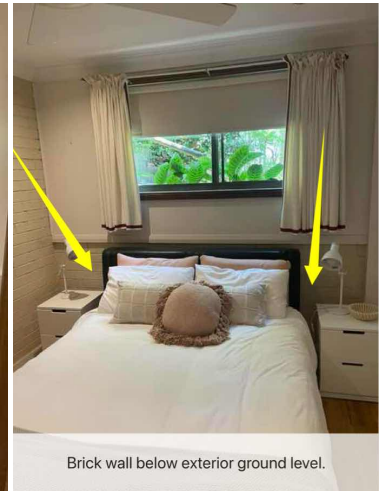
Walls are below ground level. High moisture levels obtained. Contact a licensed drainage plumber for further advice and recommendations.

Elevated moisture readings detected on the external masonry wall in bedroom five

Brick wall below exterior ground level.

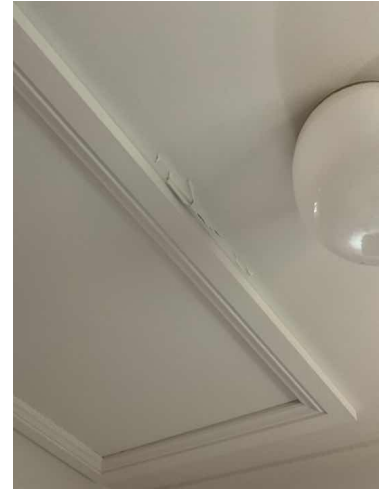
Ceiling paint flake/deterioration is evident. General maintenance / painting as required.

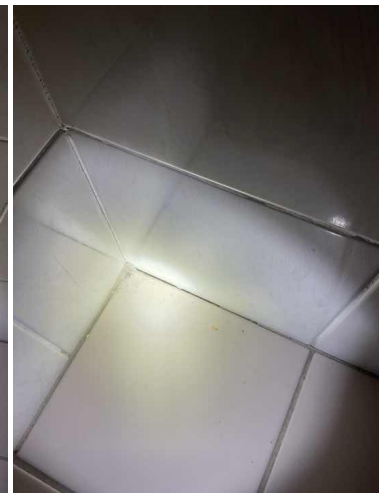
Deteriorated grout noted. This should be repaired as this will lead to water ingress under the tiles causing uplifting and possible water penetration.

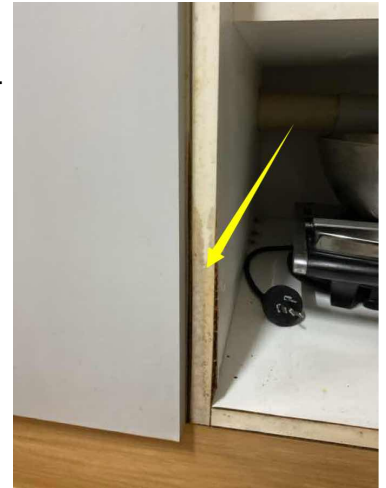
Water damage to cabinet observed. Replacement required. Contact a cabinet maker for repairs.

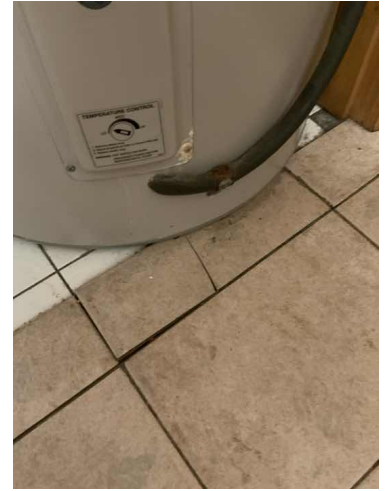
Minor cracks floor tiles. A qualified tiler should be engaged for repairs.

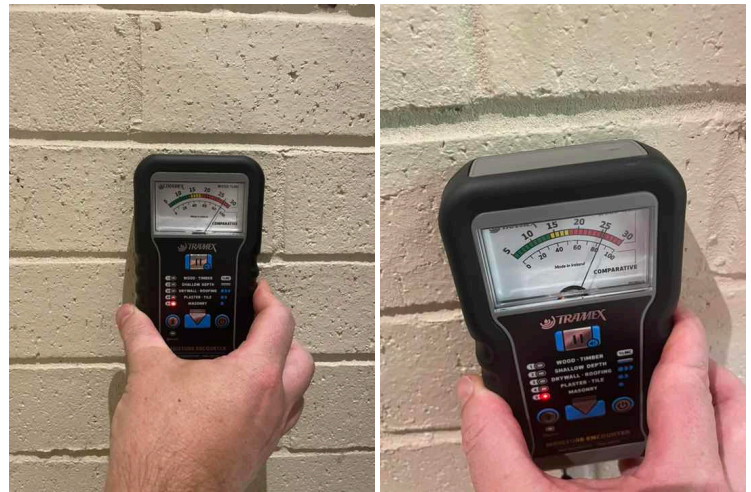
Elevated moisture readings were detected on the masonry wall located in the downstairs bedroom. At the time of the inspection moisture readings were high.
