Sample Building And Timber Pest Report

Parkway Inspections

5 Cornwall Avenue , Turramurra, NSW, 2074

Pest And Building Inspection

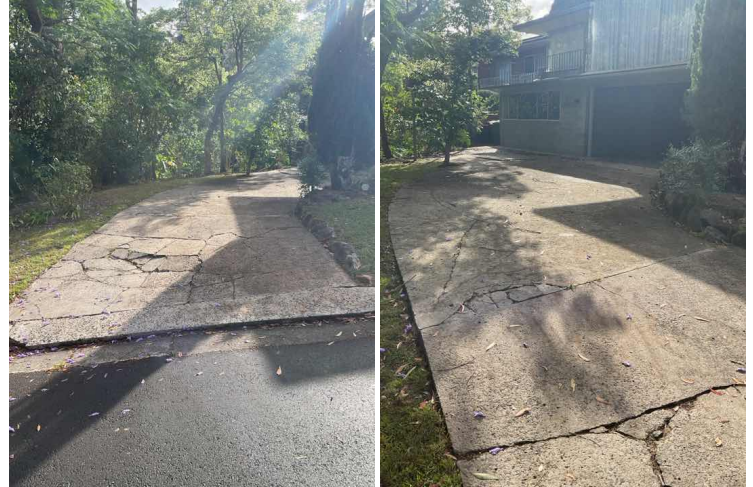
Driveway Condition

On visual inspection, the general condition of the driveway is serviceable.

Common cracks were observed on the driveway. Whilst these cracks appeared to be typical at the time of inspection, we strongly recommend you monitor these cracks and if worsening occurs contact a concreter for further advice.

Surface raised and settled in some areas. This can cause water ponding. Relaying recommended.

Driveway has visible tripping hazards. Repairs are required by a qualified concreter to avoid potential injury.

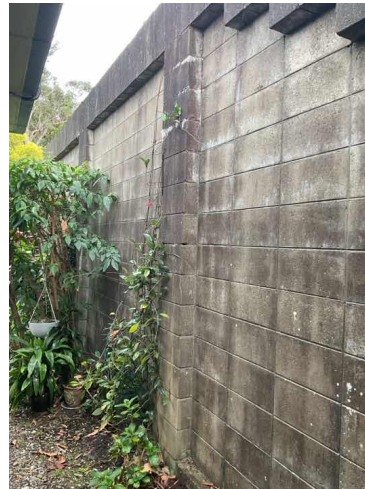
Concrete blocks have begun to break away from the solid concrete fill.

Concrete spalling noted on block wall.

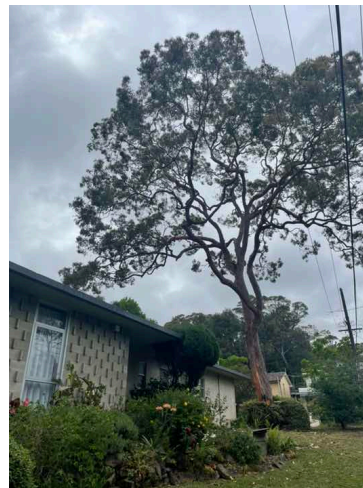
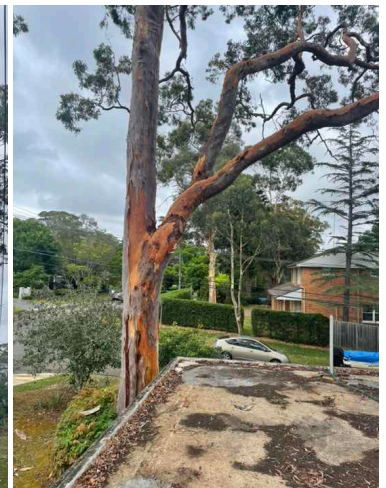
Tree Findings

Trees are close to the dwelling. These currently do not appear to have caused any defects/wall cracking. Recommendations: Engage a qualified arborist to carry out an assessment on potential issues. Trees are overhanging roof areas. These should be cut back away from the roof line and gutters.

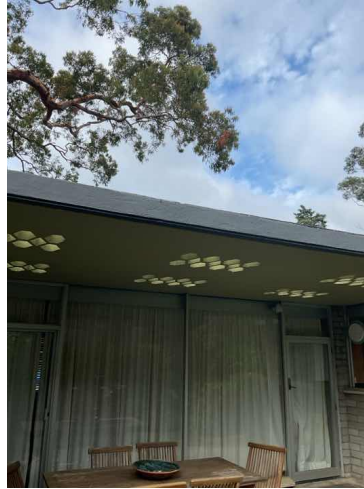
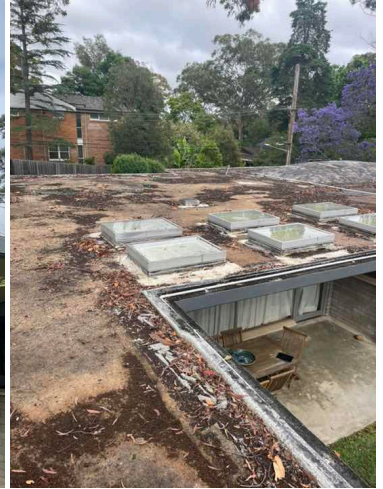
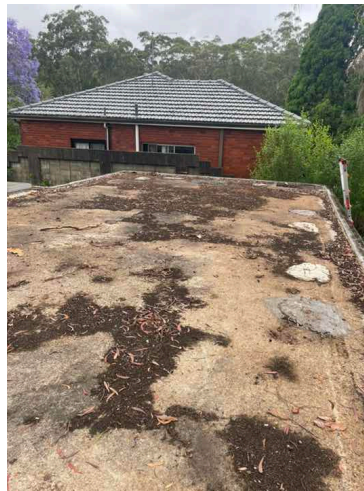
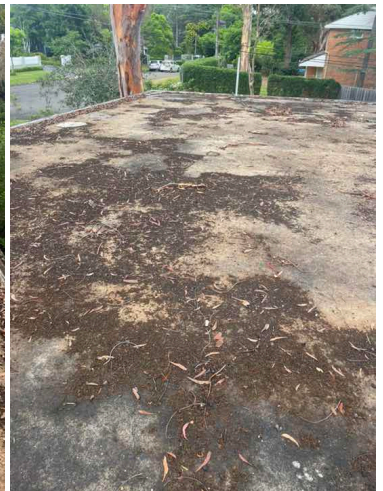
Minor section of concrete spalling.

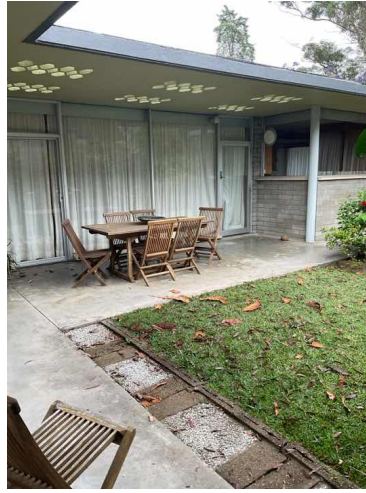
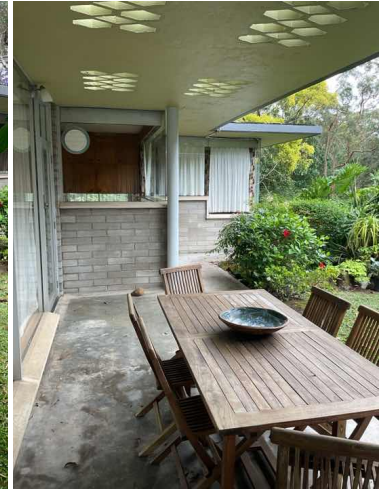
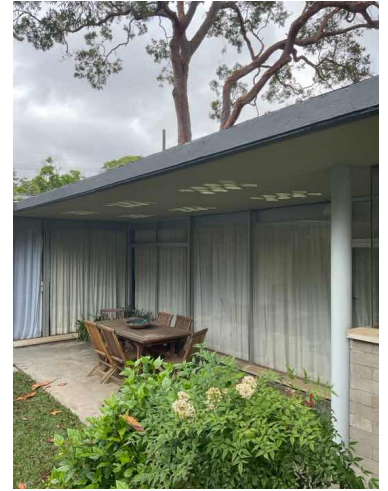
Base or Flooring Condition

Typical concrete cracks evident. These are typical for the age.
Please note: Whilst these cracks appeared to be minor and typical at the time of inspection, we recommend you monitor these cracks and if worsening occurs contact a qualified concreter for repairs.

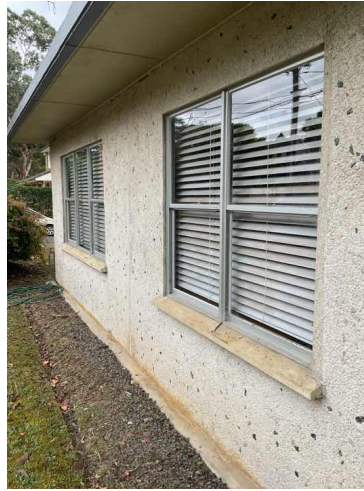
On visual inspection, the general condition of the windows is serviceable for the age.
Cracked window pane. A qualified glazier should be engaged to repair.
Deterioration of sections of window putty was observed.
A qualified glazier should be engaged for repairs.

Glazing putty has deteriorated.

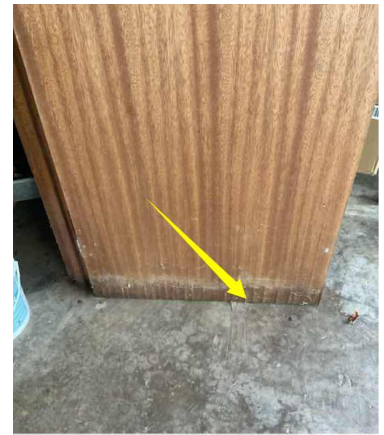
General age deterioration of the garage door/components. Recommendations:
General repairs/maintenance as required.

Minor water damage to garage storage door.

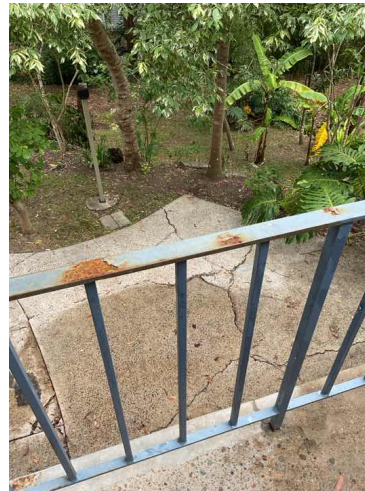
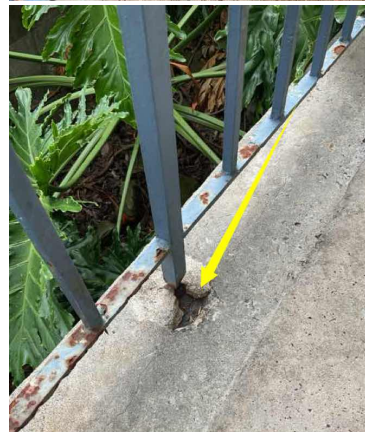
Balustrade Condition

Baluster rail height should be 1 m in height from deck/balcony/patio floor. In some circumstances this regulation was non-existent dependent on the age of the dwelling and technically there is no requirement to rectify. We strongly advise you rectify to comply for safety concerns.

Corrosion noted to the balustrades, we recommend repairing these so as to preserve the integrity of the balustrade.

Concrete spalling and erosion to metal balustrade.

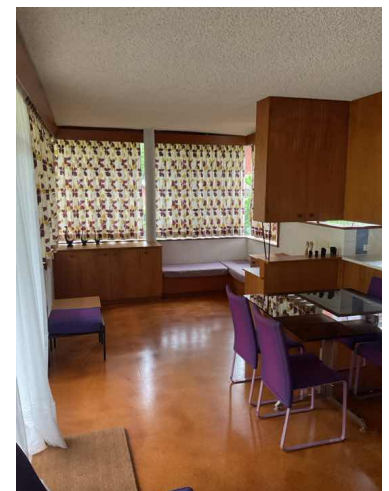
General age wear deterioration - The window frame/ components showed evidence of ageing and wear. General maintenance works required.

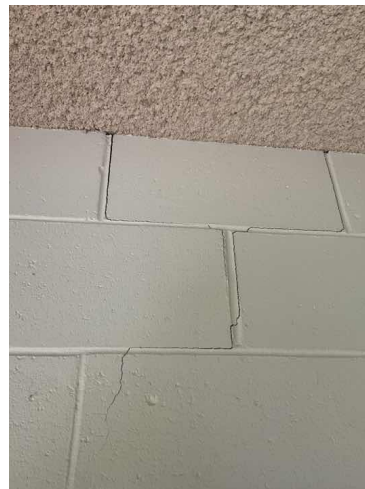
Blockwork cracks noted. These are typical and generally patch and paint will suffice, however we recommend you monitor these cracks and if they become wider or longer you will need to contact a structural engineer to assess.

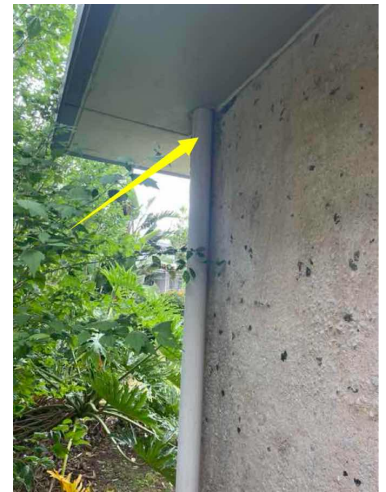
Ceiling stains - No moisture readings obtained. These may have been repaired however you will need to monitor after a prolonged period of rainfall. If leaking persists, a qualified plumber should be engaged for repairs.

This water stain is adjacent to the external down pipe for the roof. An old leak that seems to have been rectified.

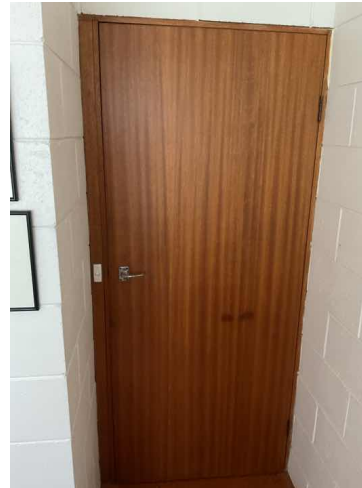
Uneven / out of square door causing binding. A qualified carpenter should be engaged to refit.

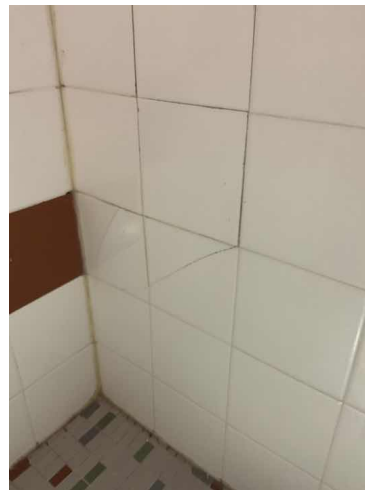
Tile grout deterioration to tiles to the shower area. Re-grout / seal. A qualified tiler should be engaged for recommendations and repairs, as water may seep in creating conducive conditions for termites.

Cracked tile/s noted. With water leaking through the cracks, water may seep in creating conducive conditions for termites. A qualified Tiler should be engaged for advice and recommendations.

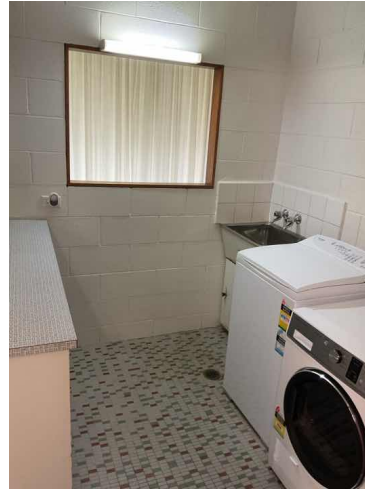
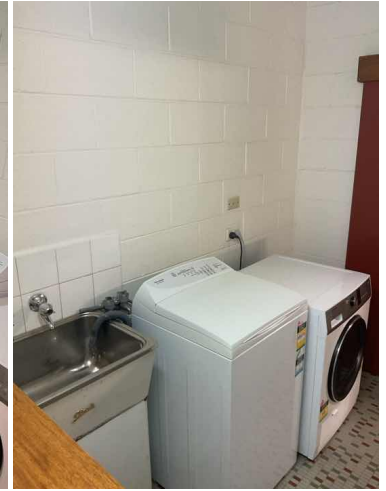
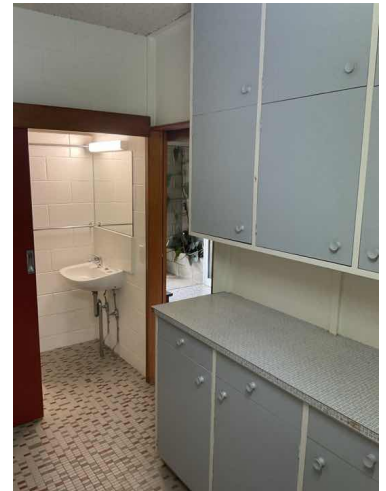
Tub is corroded. Replacement recommended.
