Sample Building And Timber Pest Report

Parkway Inspections

14 The Walk, Murrays Beach, NSW, 2281

Pest And Building Inspection

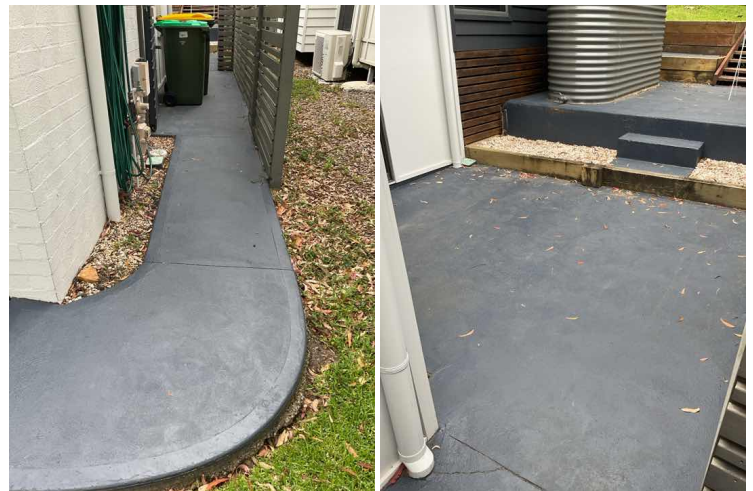
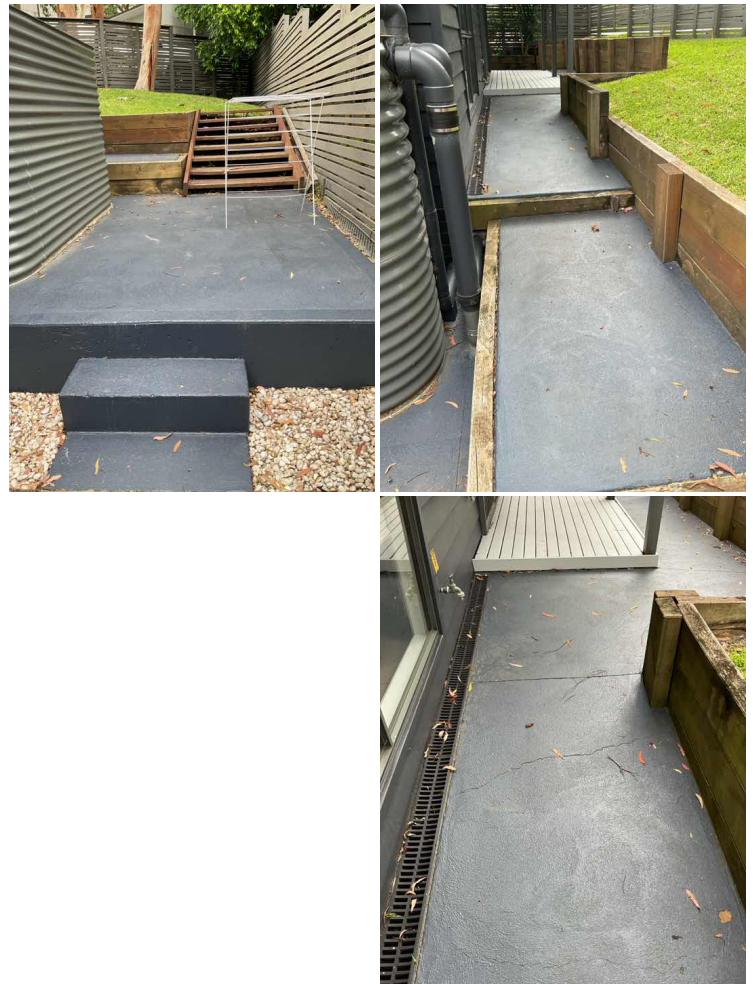
Common cracks and settlement were observed on paths. Whilst these cracks appeared to be typical at the time of inspection, we strongly recommend you monitor these cracks and if worsening occurs contact a concreter for further advice.

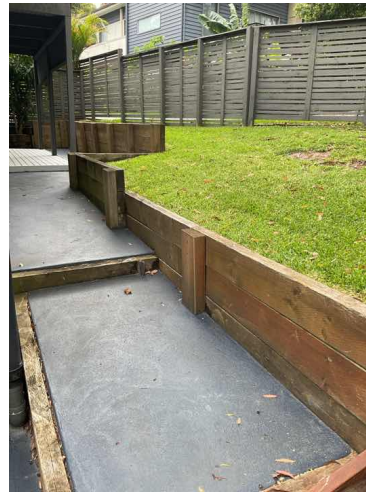
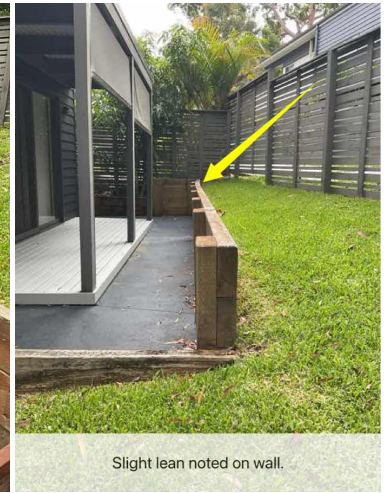
Slight lean noted on wall.

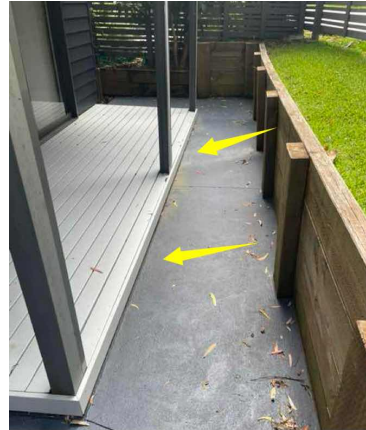
The ground levels along the perimeter walls at the rear of the home did not appear to fall away from the property walls sufficiently due to the natural landscape and contour. This will need to be assessed during a period of rainfall and if surface water appears to be entering the sub floor if applicable or ponding against the perimeter walls, engage a plumber or landscaper to assess and rectify as required. All drains should be regularly checked by a plumber and kept clean of debris to allow surface water to be carried away from the dwelling.

Concrete path falling towards the home.

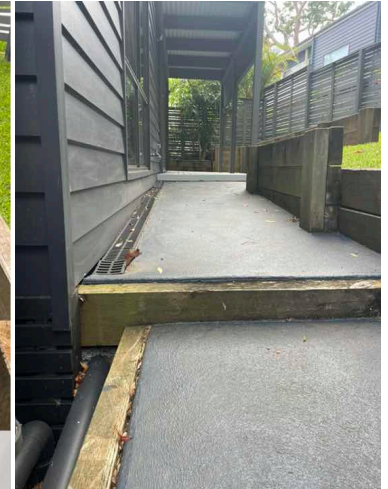
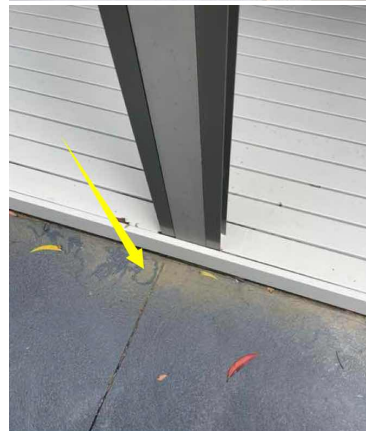
Evidence of water ponding.

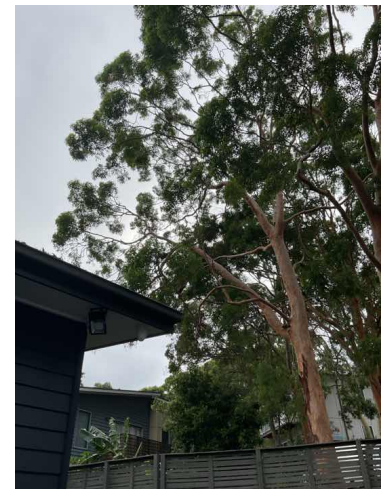
Trees are close to the dwelling. These currently do not appear to have caused any defects/wall cracking. Recommendations: Engage a qualified arborist to carry out an assessment on potential issues.

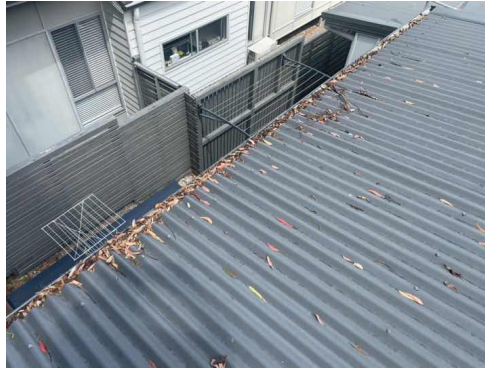
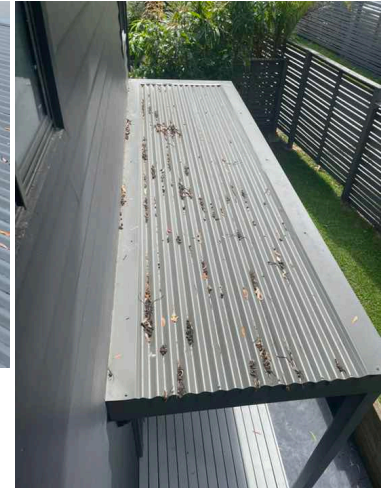
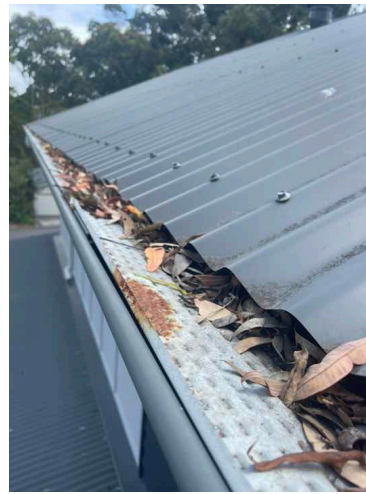
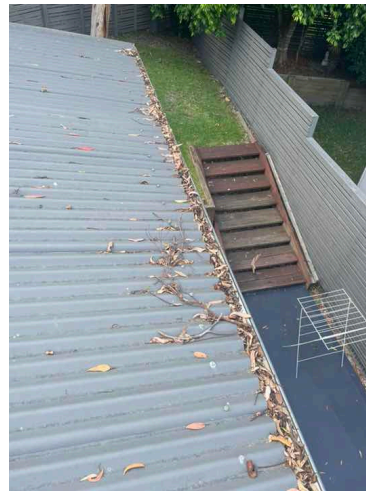
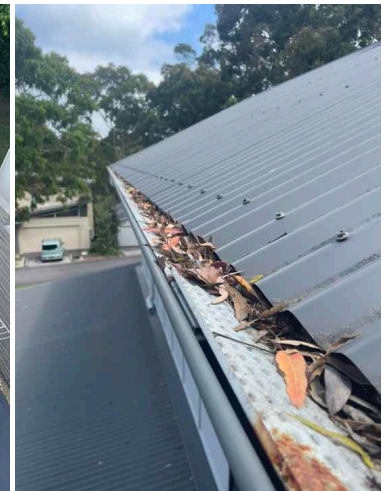
Debris in guttering areas- this requires cleaning out to prevent blocking of downpipes and leaking into eaves and fascia. Have gutters cleaned and assessed by a plumber for adequate fall. Regularly clean to prevent ponding. Ponding water will contribute to rust.

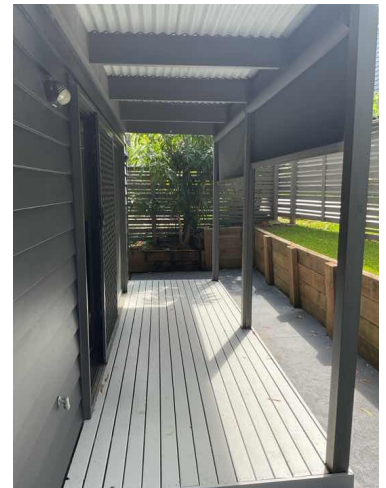
Timber fungal decay in section of bearers or joists. This is a safety hazard and repair is required. A qualified carpenter should be engaged to replace all affected timbers.

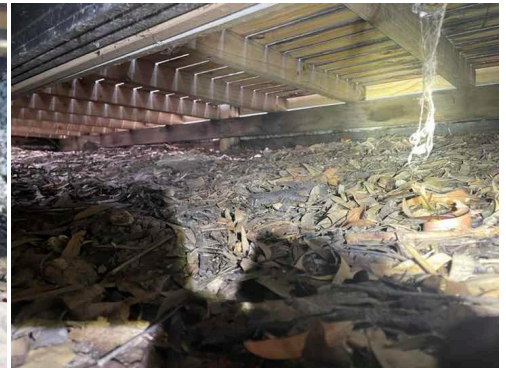
Timber decay evident. Underside of decking.

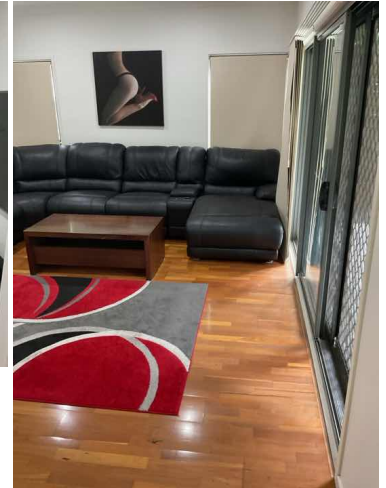
Timber flooring not finished under skirting boards, small gap noted.

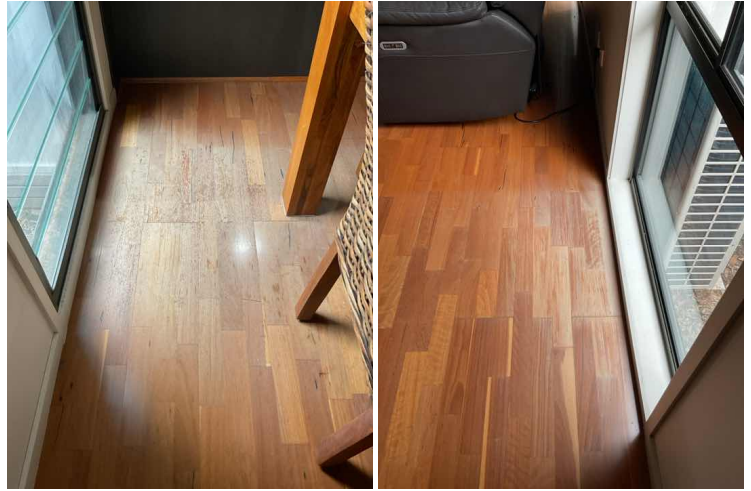
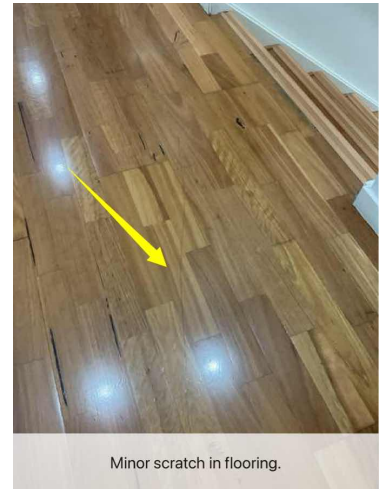
Timber laminate flooring appears to have faded due to sun exposure.

Minor scratch in flooring.

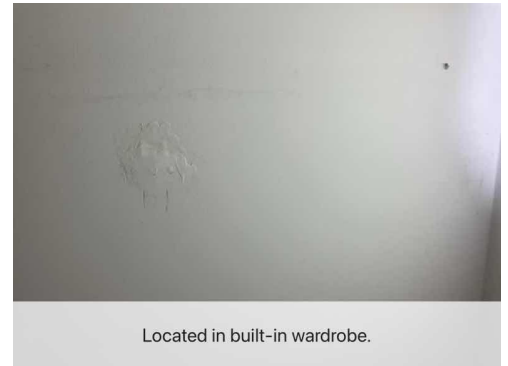
Incomplete Patch/Paint repairs noted. I recommend you contact a qualified painter for repairs.

Located in built-in wardrobe.

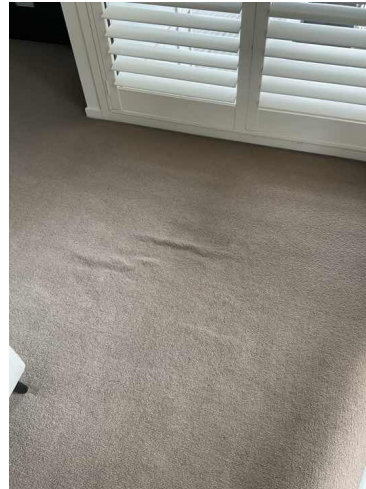
Stains observed - Steam cleaning may rectify stained areas but they appear entrenched.
Carpet appears dilapidated and may re-stretching.
Check with a qualified carpet layer if this is feasible.

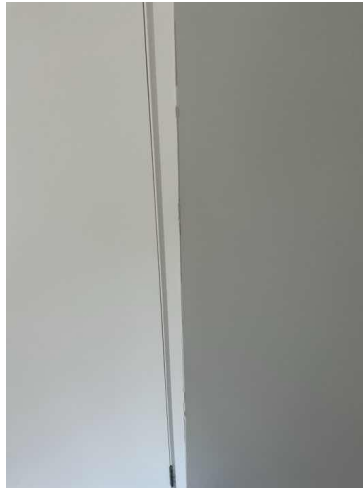
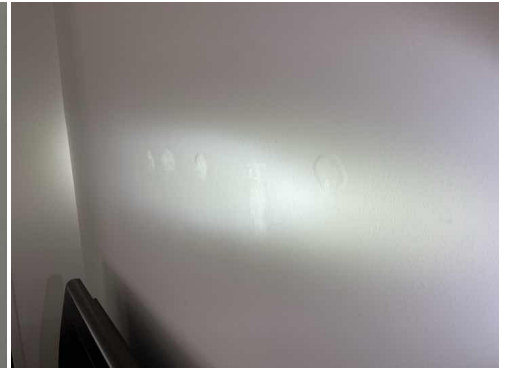
Settlement Cracks Noted. These are typical and generally patch and paint will suffice, however we recommend monitor these cracks and if become wider or longer, you will need to contact a structural engineers to assess. Incomplete Patch/Paint repairs noted. I recommend you contact a qualified painter for repairs.

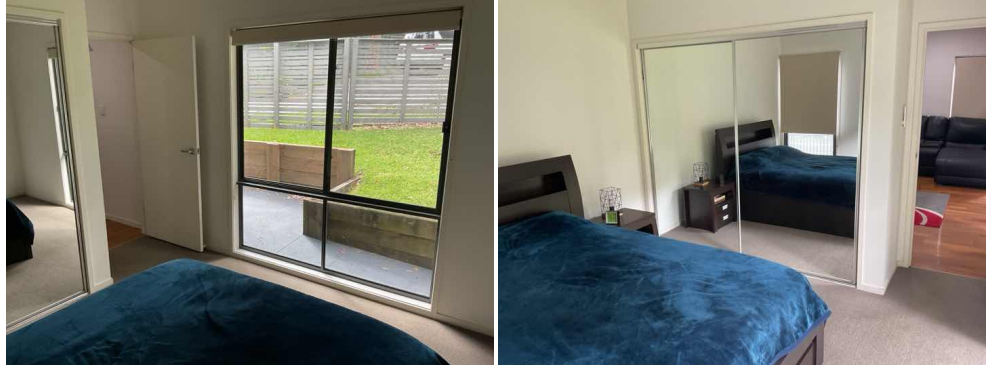
Typical cornice separation/detachment observed. I recommend you contact a qualified painter for repairs. Incomplete patch/paint repairs noted. I recommend you contact a qualified painter for repairs.

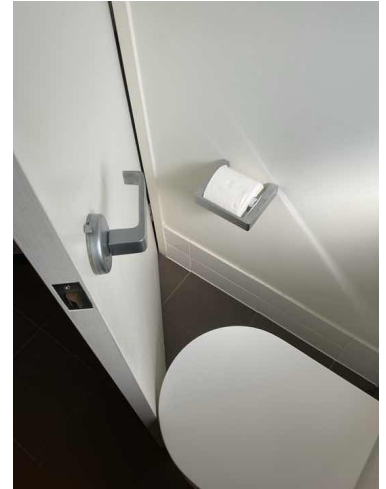
Door stop should be fitted , door hits toilet

Recommendations: A qualified carpenter should be engaged for advice and recommendations.

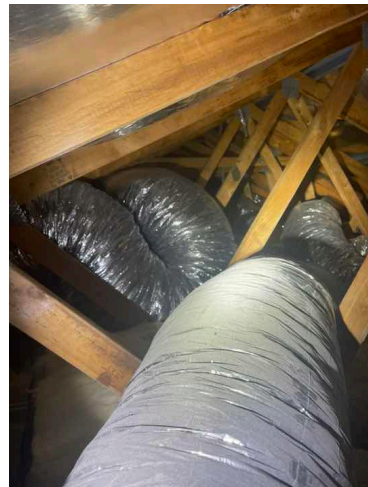
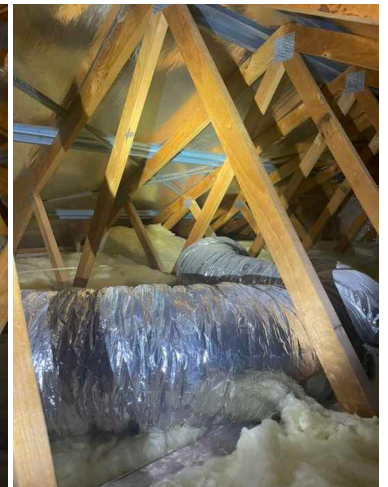
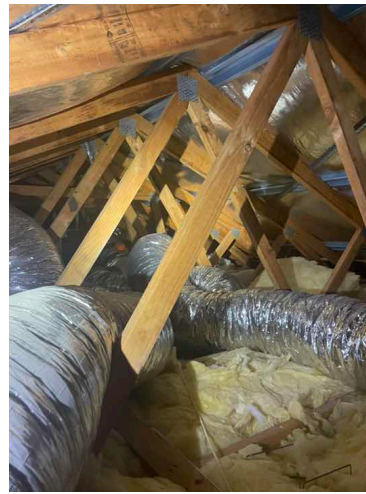
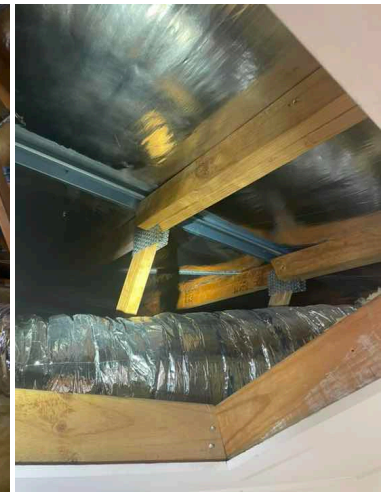
Truss Webbing

There is heating and/or cooling ducting present in the roof space. This is preventing a full inspection from being undertaken. It is strongly recommended that full access be gained as it could be harbouring timber pest activity, damage or defects.

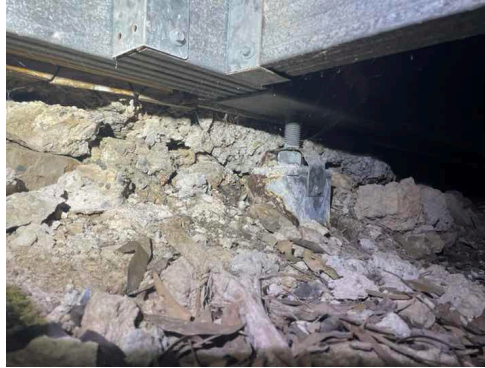
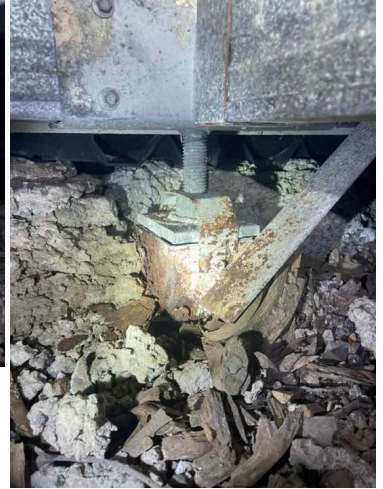
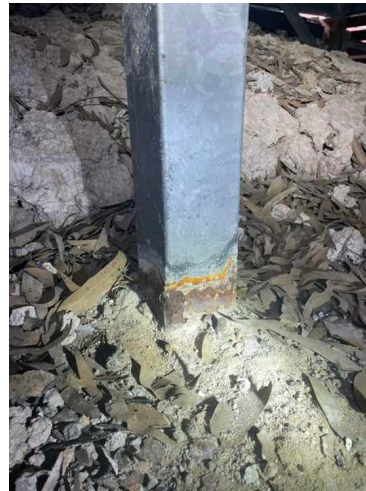
Minor corrosion observed on posts.

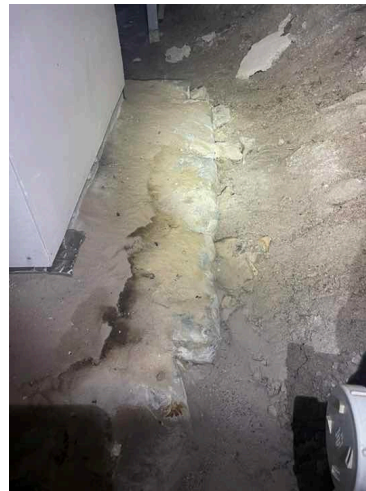
Dampness in sub floor soil. Damp sub floor soil should be avoided as it can cause fungal decay, mould and possibly footings problems. Recommendations: A qualified drainage plumber should be engaged for advice and recommendations.

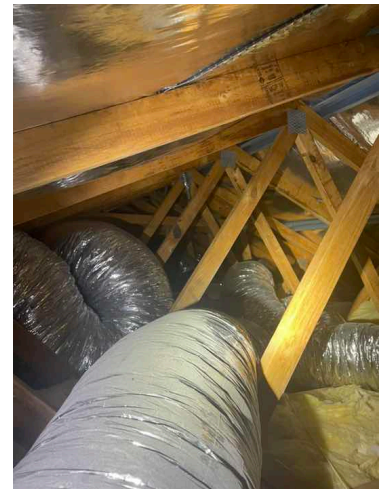
Roof void sections were not visible.
No inspection made or report submitted to any concealed timber frames.
