# Sample Report

## Parkway Inspections

**44 Rayner Rd, Whale Beach, NSW, 2107**

### Pest And Building Inspection

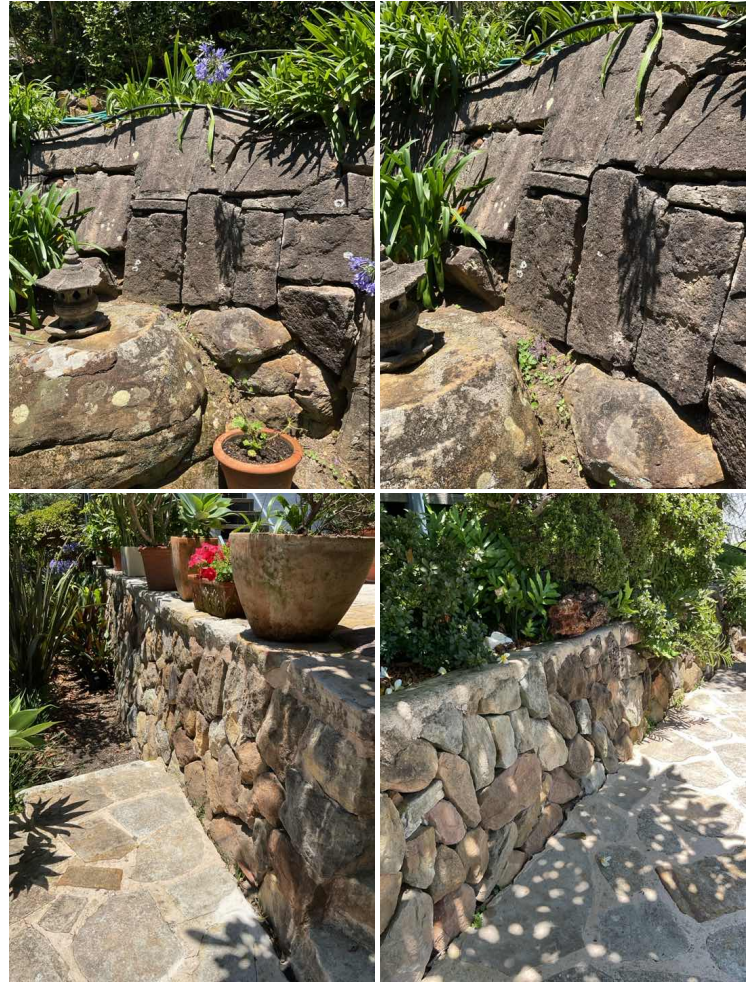
Retaining wall cracking. Normally this occurs if adequate drainage has not been provided (Ag Line) or a poor footing system or a combination of reasons. A qualified brick layer should be engaged for advice and recommendations.

Retaining wall leaning due to deterioration and age. A qualified brick layer should be engaged for advice and recommendations.

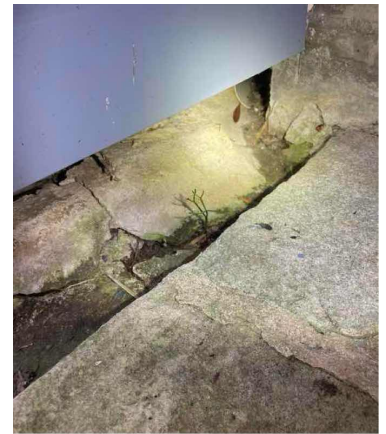
Not the best practice to channel stormwater beneath the property in this manner.

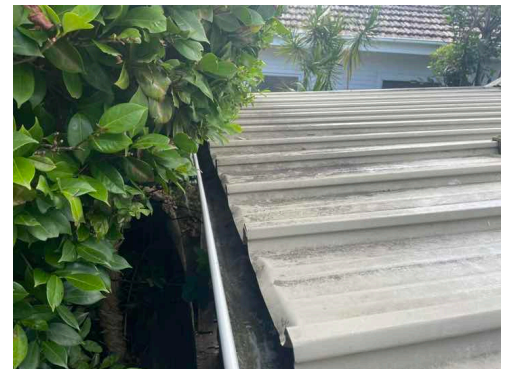
Trees are close to the dwelling. These currently do not appear to have caused any defects/wall cracking. Recommendations: Engage a qualified arborist to carry out an assessment on potential issues.

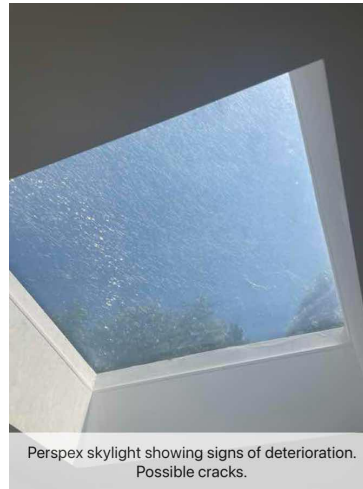
Perspex skylight showing signs of deterioration.  
Possible cracks.

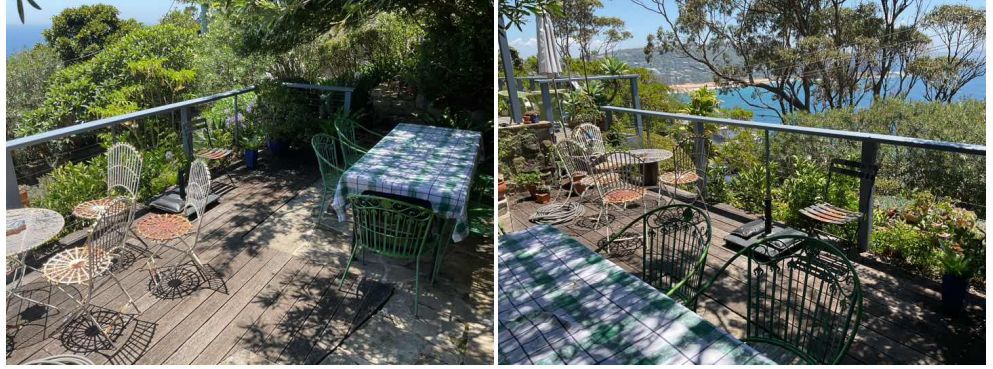
General timber decay in decking components. A qualified carpenter should be engaged for advice and recommendations.

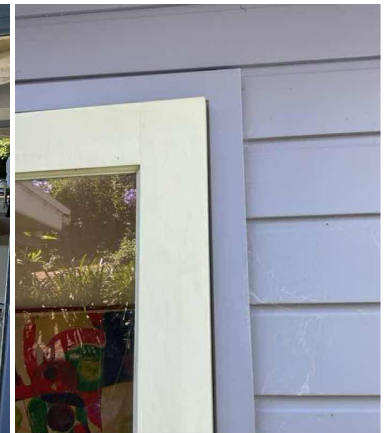
External door located in hallway.

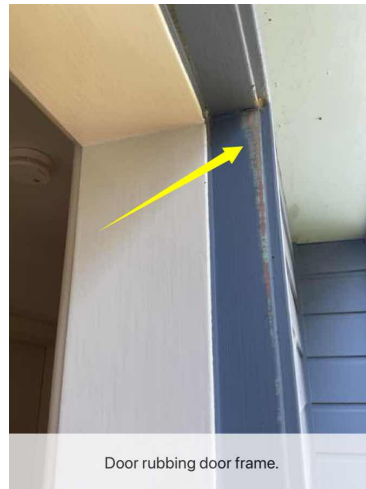
Door uneven/out of square - This can relate to some differential settlement in the footings, frame movement, age, expansion, shrinkage and the like.

Door rubbing door frame.

Recommendations: A qualified carpenter should be engaged for advice and recommendations.

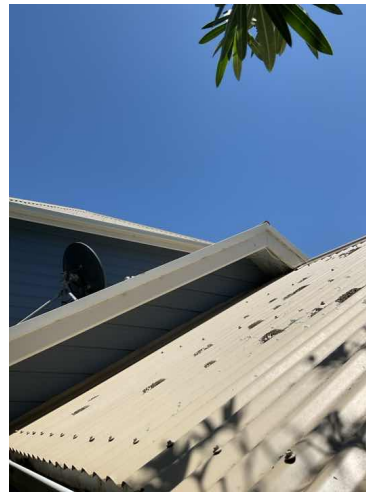
On visual inspection, the general condition of the fascia/barge boards is serviceable. Paint / finish was deteriorated in areas and is in need of maintenance - Sanding back affected areas and painting required. Timber fungal decay (rot) visible. Recommendations: A qualified carpenter should be engaged to replace all affected timbers.

Minor timber decay noted.

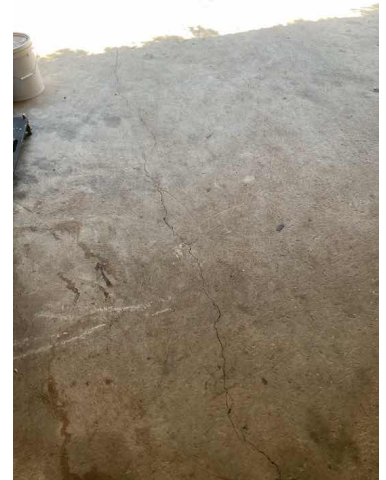
Minor hairline slab cracks - Note. Whilst these cracks appeared to be minor at the time of inspection, we strongly recommend you monitor these cracks and if worsening occurs contact a qualified concreter for further advice.

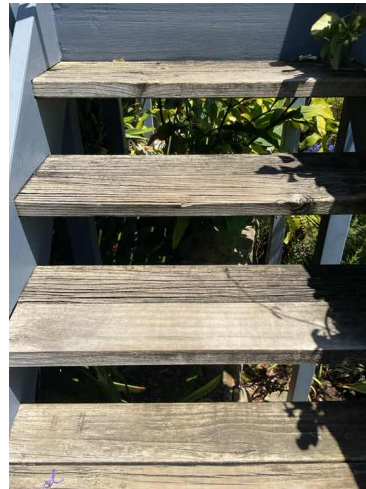
Timber fungal decay in sections of stair treads. This is a safety hazard and repair is required. A qualified carpenter should be engaged for advice and recommendations.

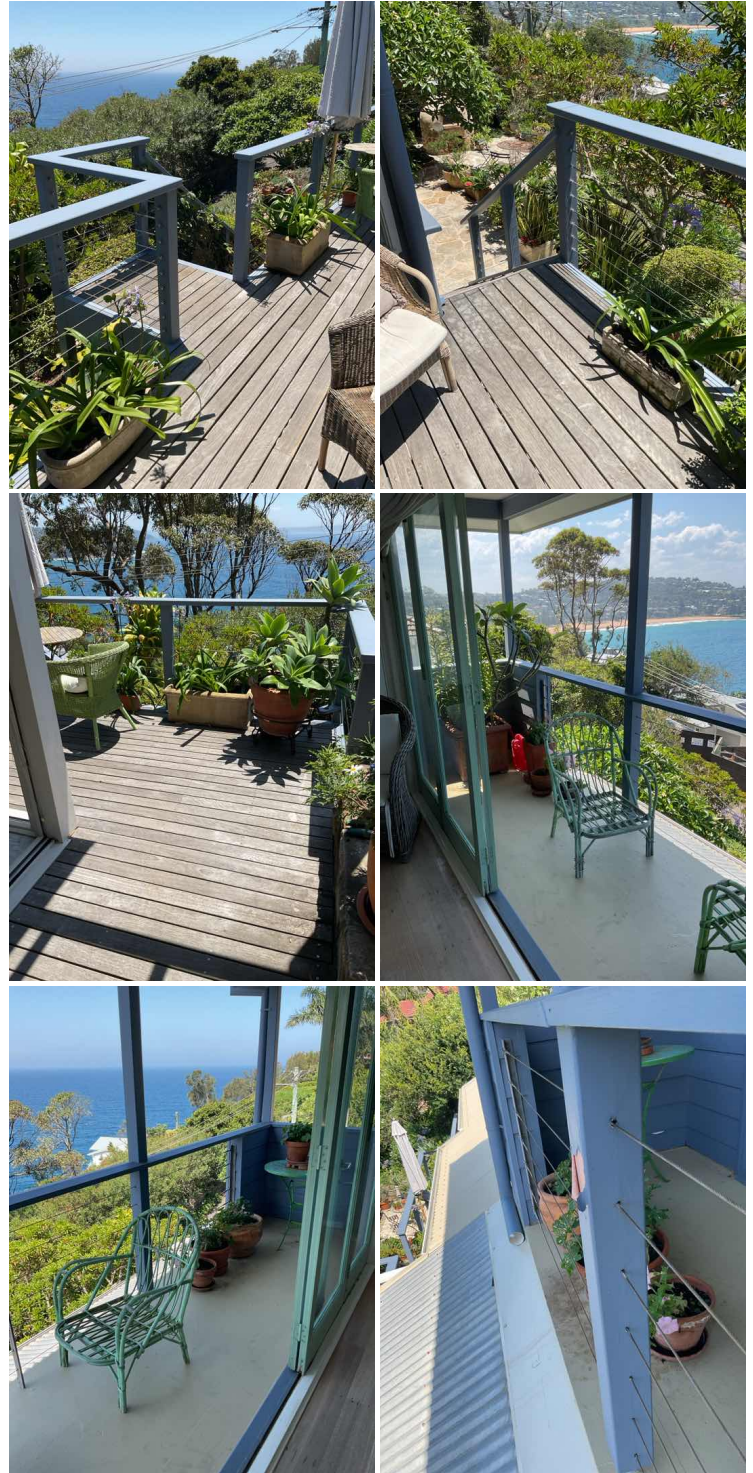
Timber decay evident on rails / balustrade. A qualified carpenter should be engaged for advice and recommendations.

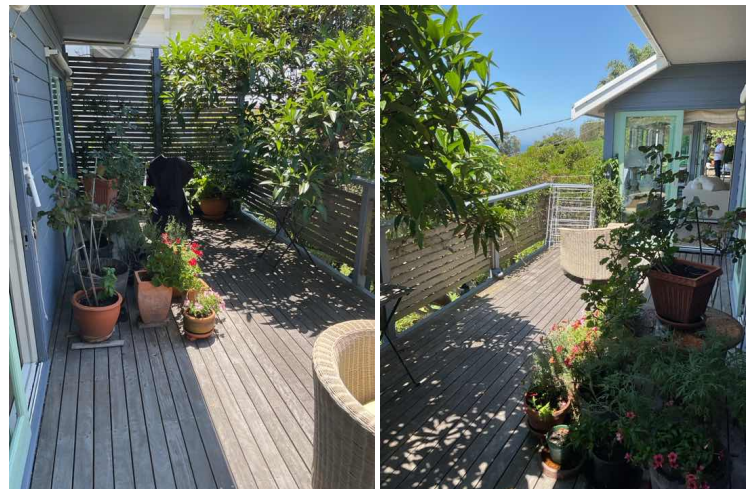
Moisture damage was observed. Recommendations: Recommend evaluation and repairs by a qualified contractor/carpenter.

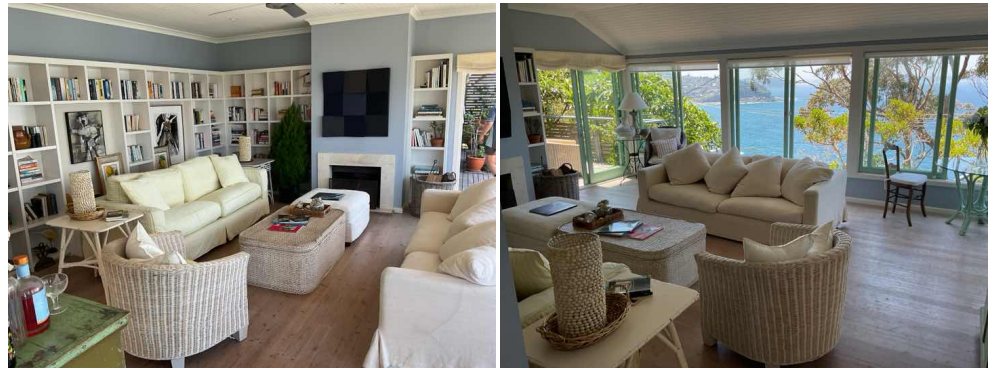
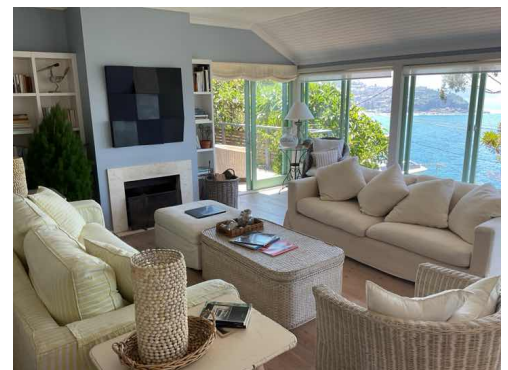
Minor scratches noted on the timber floor.

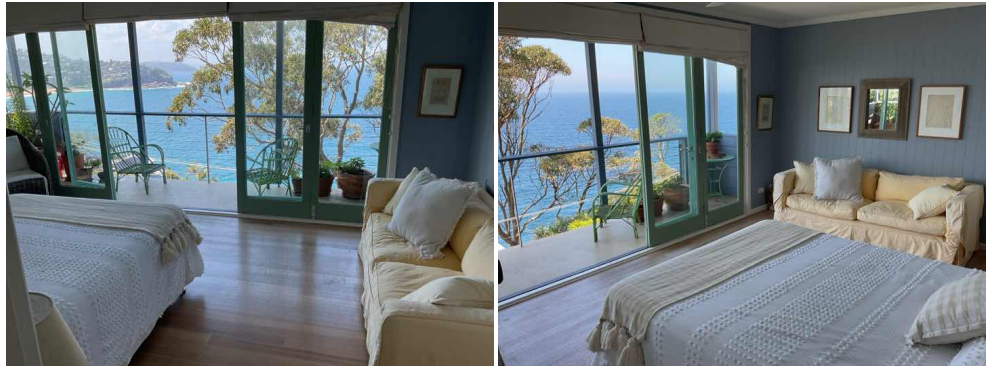
Door lock hardware is loose possibly damaged. Maintenance as required.

Hinge screws missing / loose - Maintenance as required.

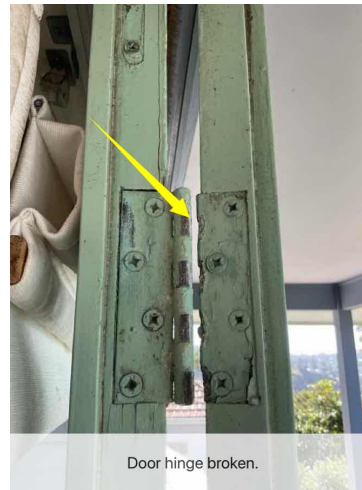
Door hinge broken.

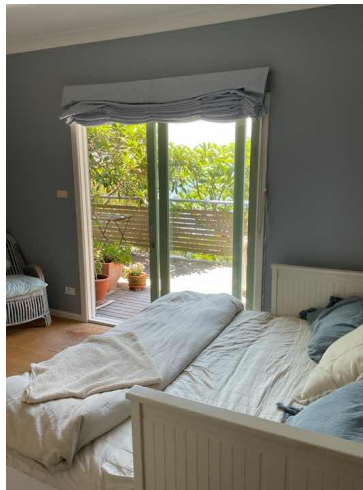
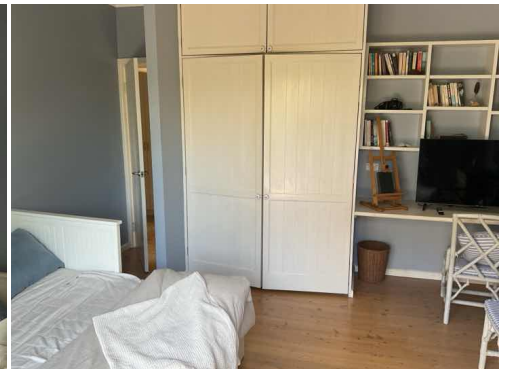
Stained timber flooring - This is normally due some water penetration. This will not be able to be removed and options include replacement, staining all the boards dark or lining same to cover. A qualified carpenter should be engaged for advice and recommendations.

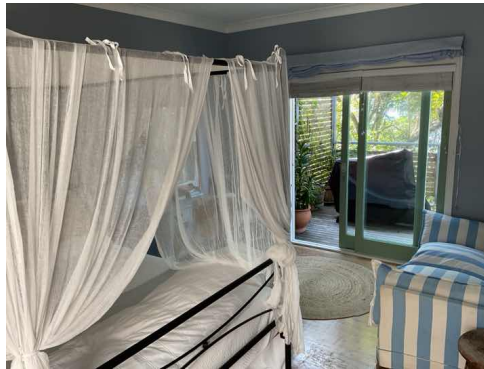
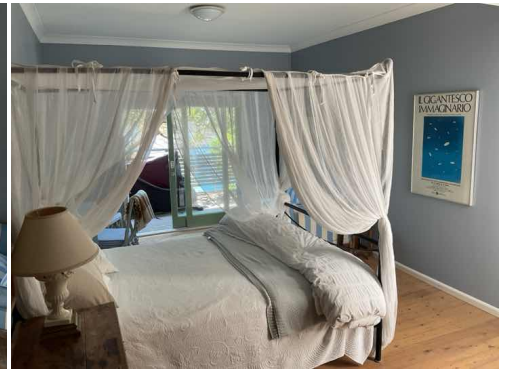
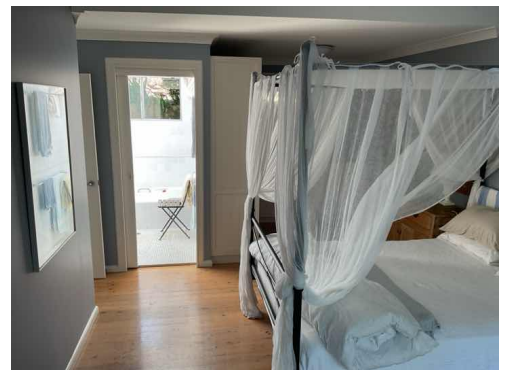
Door / frame deterioration - General age/damage has occurred to door frame, face or components. A qualified carpenter should be engaged for advice and recommendations.

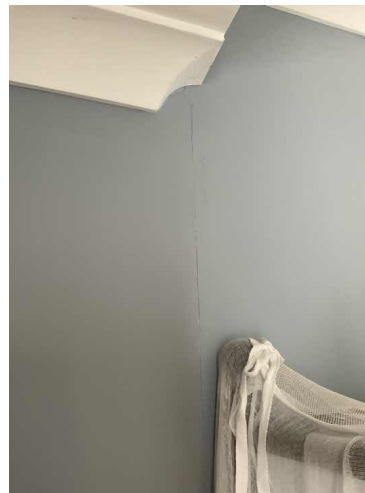
Settlement Cracks Noted. These are typical and generally patch and paint will suffice, however we recommend monitor these cracks and if become wider or longer, you will need to contact a structural engineers to assess.

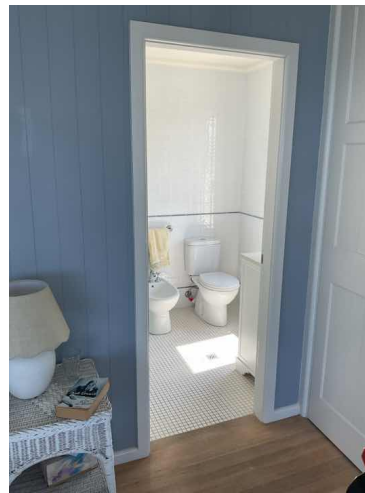
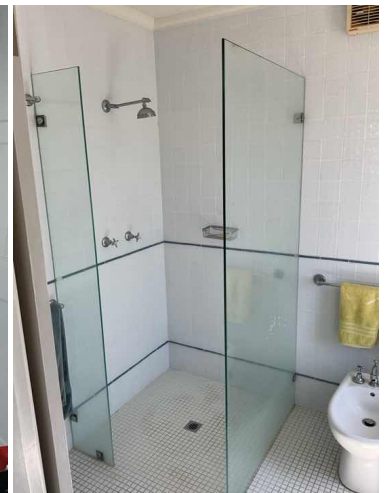
Binding/out of square door frame - This can relate to some differential settlement in the footings, frame movement, age, expansion, shrinkage and the like. A qualified carpenter should be engaged for advice and recommendations.

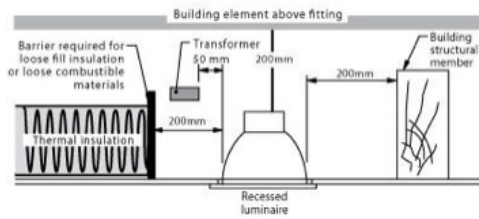
Insufficient spacing between insulation and down lights.

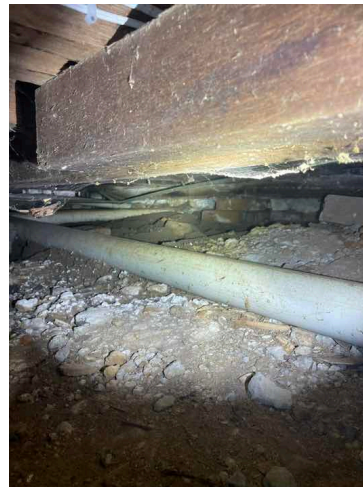
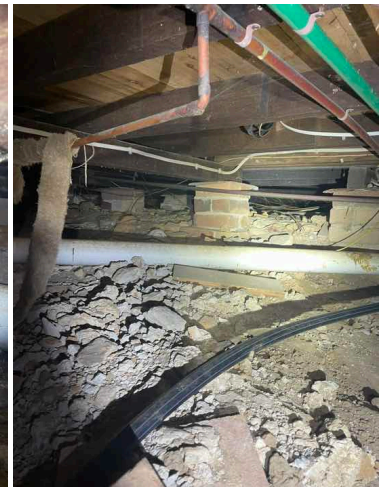
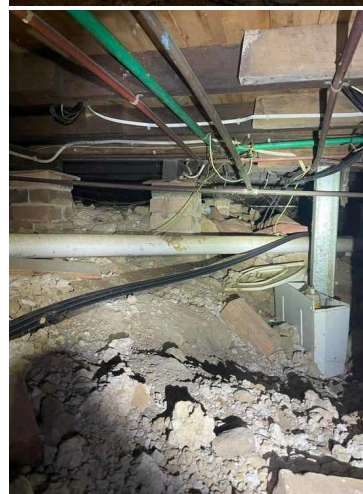
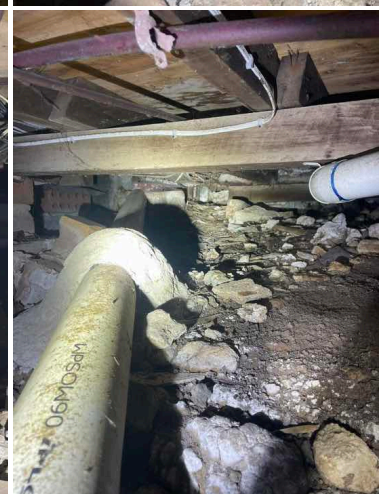
Low access restricted full visual inspection.

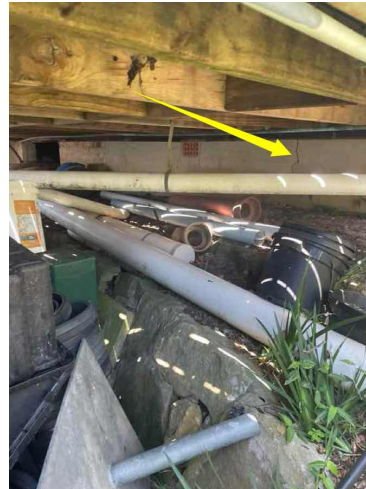
Brick fretting to piers visible. (Bricks breaking to powder form from salts and minerals due to moisture) A qualified brick layer and drainage expert should be engaged for advice and recommendations.

Cracking was evident to the foundation walls. Underpinning may be required to prevent further movement and cracking. We recommend you contact a qualified brick layer and a practicing structural engineer for recommendations and advice.

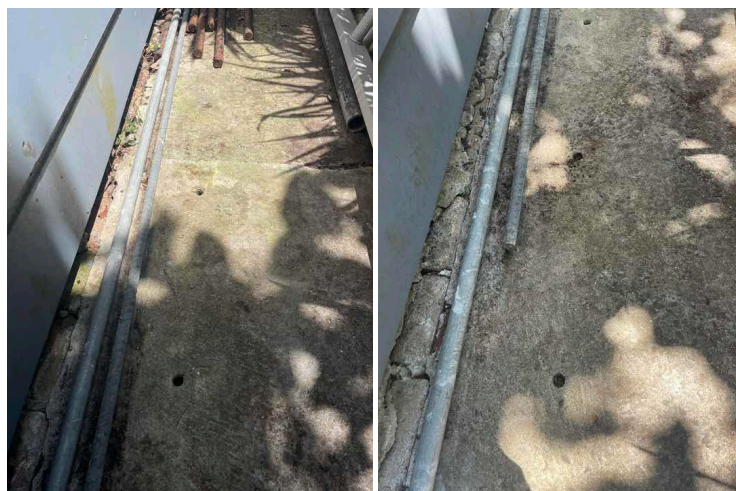
Yes, Drill Holes (Chemical Treatment) were located at the property.

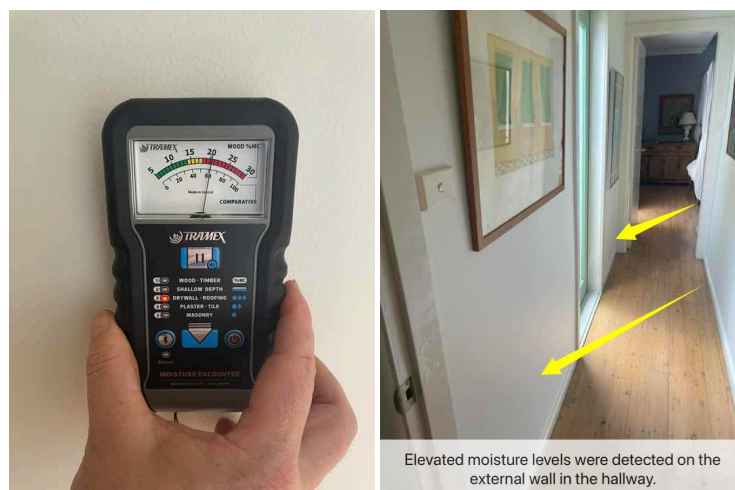
At the time of the inspection moisture readings were high.
