Sample Building And Timber Pest Report

Parkway Inspections

56 Cowmeadow Road, Mount Hutton, NSW, 2290

Pest And Building Inspection

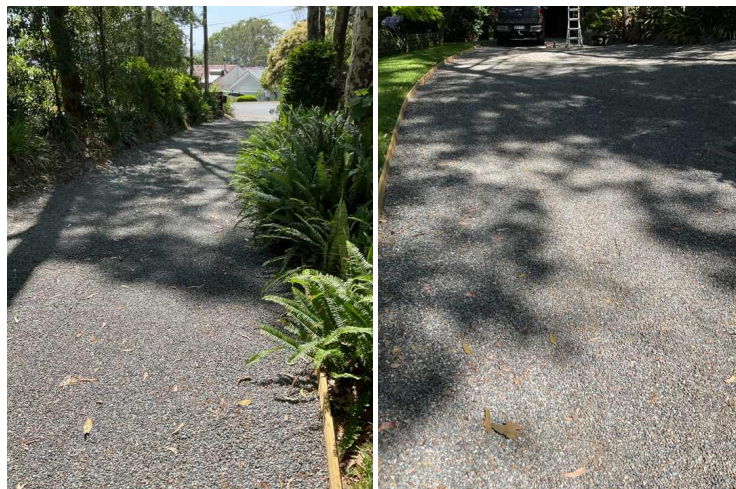
On visual inspection, the general condition of the driveway is serviceable.

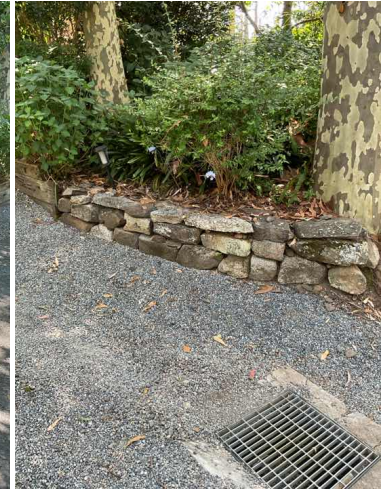
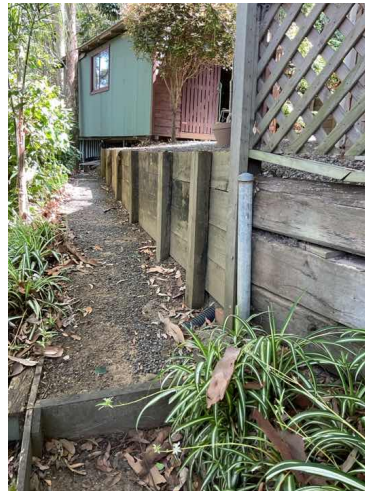
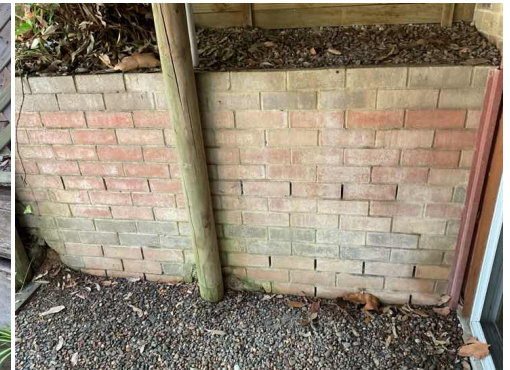
The retaining wall material is stone.

The retaining wall material is wood / timber.

Of the visible areas, the general condition is serviceable or in reasonable condition for age of dwelling.

Timber fungal decay evident. Recommendations: A qualified landscaping contractor should be engaged for repairs and recommendations.

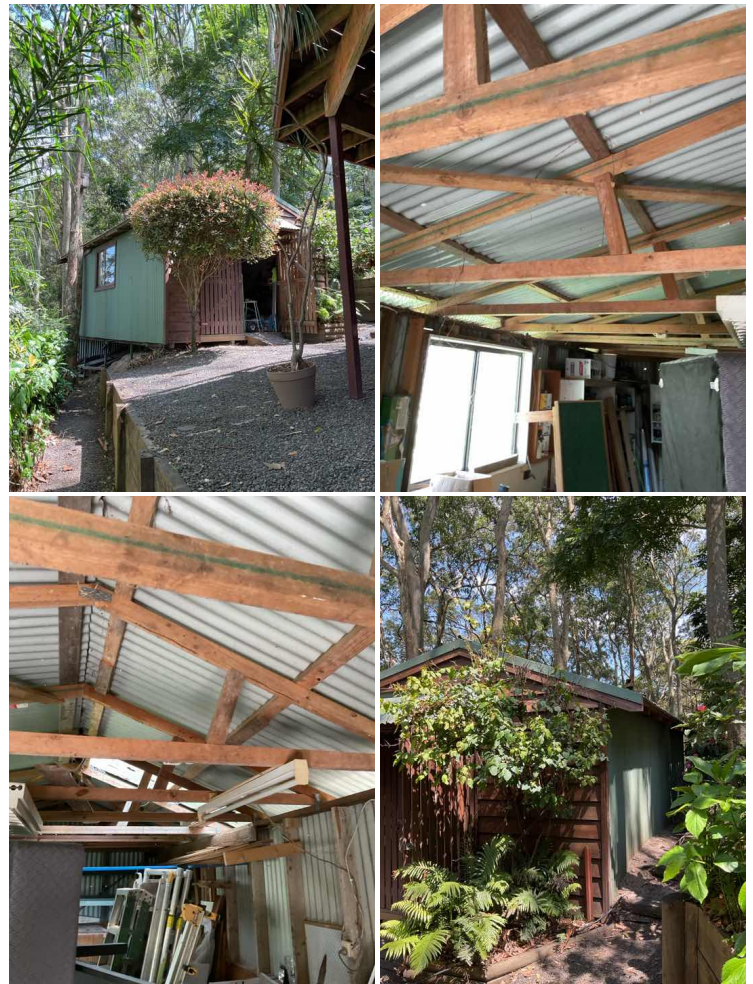
The shed is in fair usable condition.

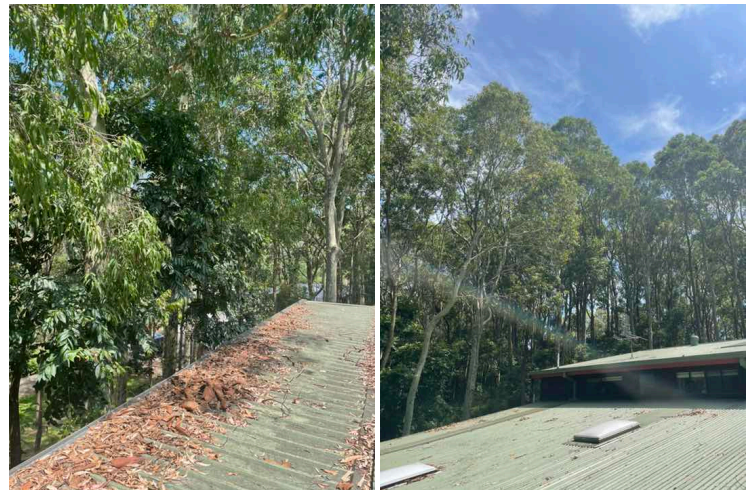
Trees are close to the dwelling. These currently do not appear to have caused any defects/wall cracking. Recommendations: Engage a qualified arborist to carry out an assessment on potential issues. Trees are overhanging roof areas. These should be cut back away from the roof line and gutters.

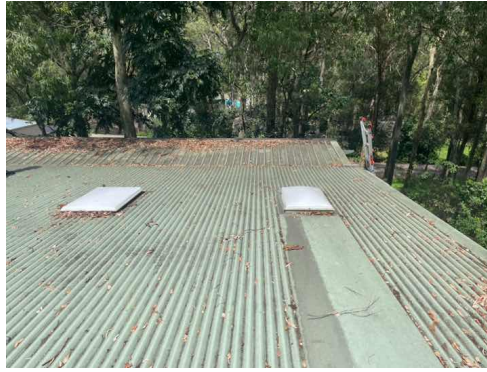
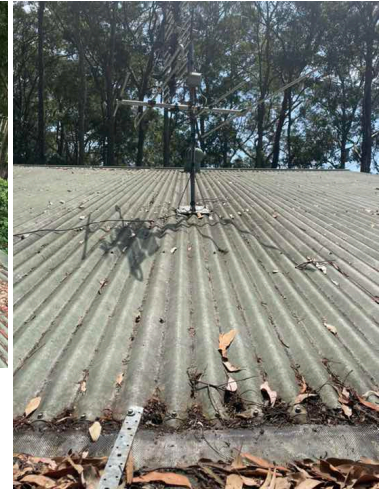
Of the visible areas, the general condition of the roof is in serviceable condition for the age.

Visible section of The roof cladding appeared in a serviceable condition for the age of this dwelling. Annual maintenance inspection recommended.

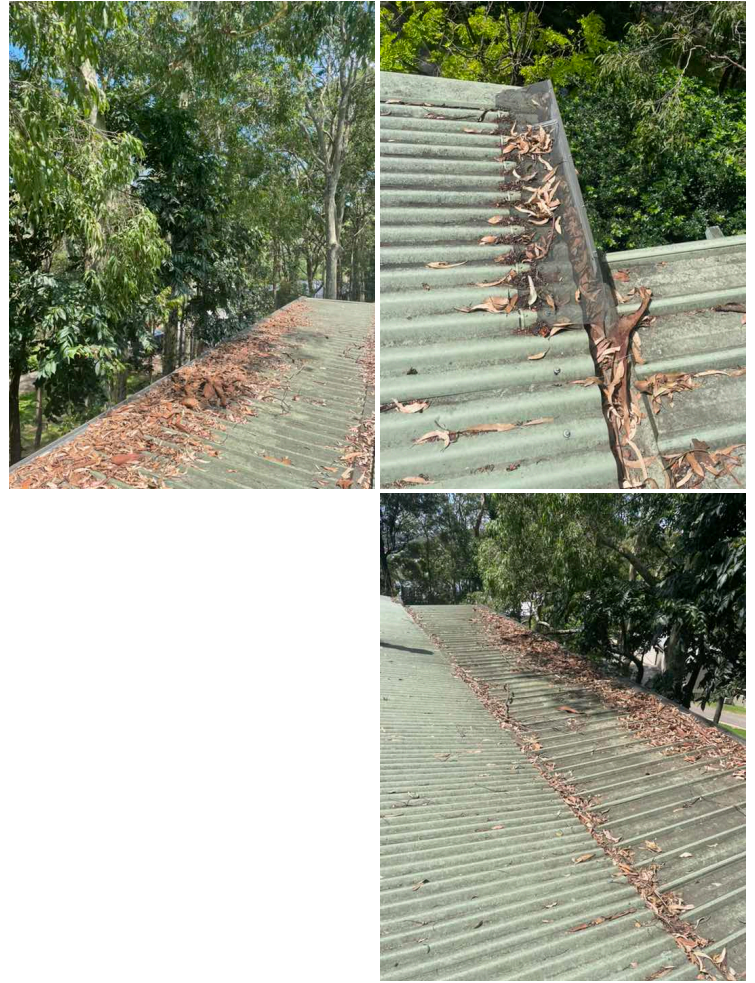
Debris in guttering areas- this requires cleaning out to prevent blocking of downpipes and leaking into eaves and fascia. Have gutters cleaned and assessed by a plumber for adequate fall. Regularly clean to prevent ponding. Ponding water will contribute to rust.

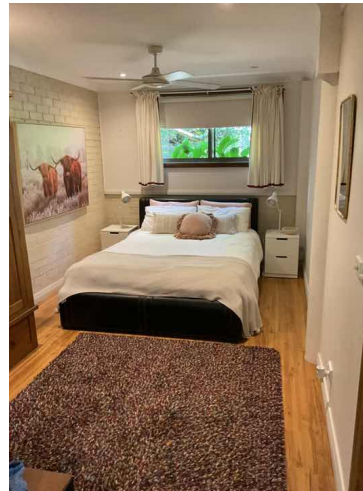
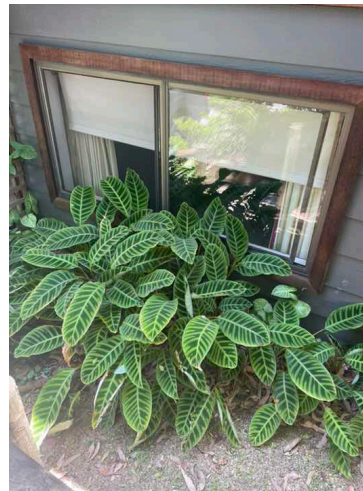
Brick wall below exterior ground level.

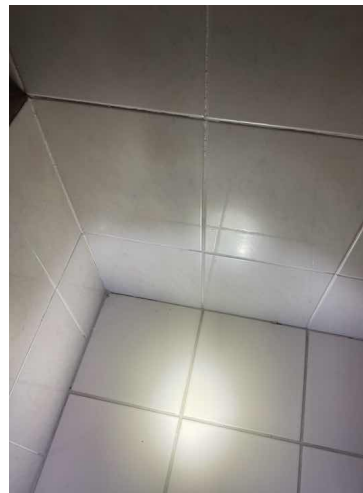
Flooring

Deteriorated grout noted. This should be repaired as this will lead to water ingress under the tiles causing uplifting and possible water penetration.

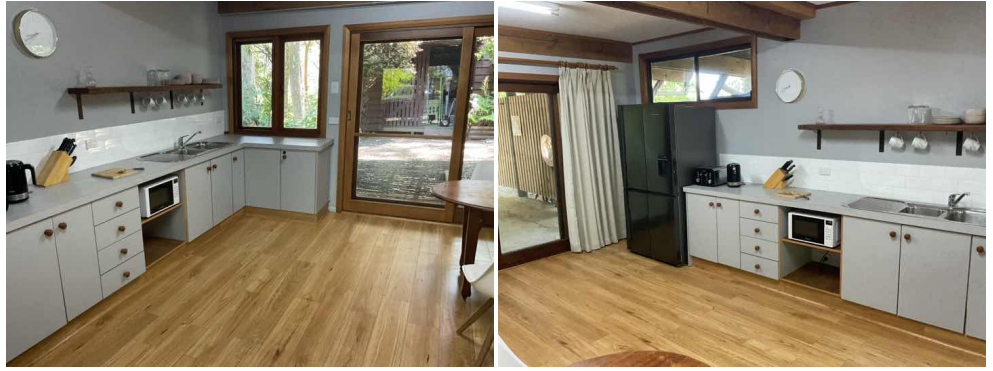
Cupboards And Bench Tops

Water damage to cabinet observed. Replacement required. Contact a cabinet maker for repairs.

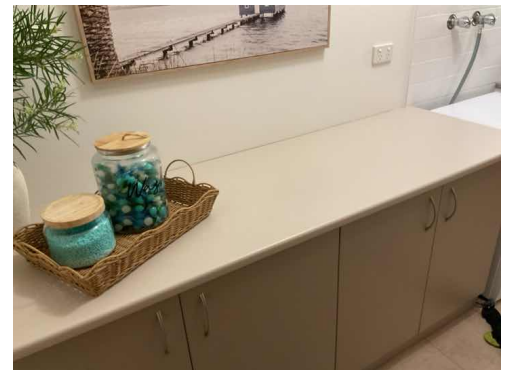
Floor

Minor cracks floor tiles. A qualified tiler should be engaged for repairs.

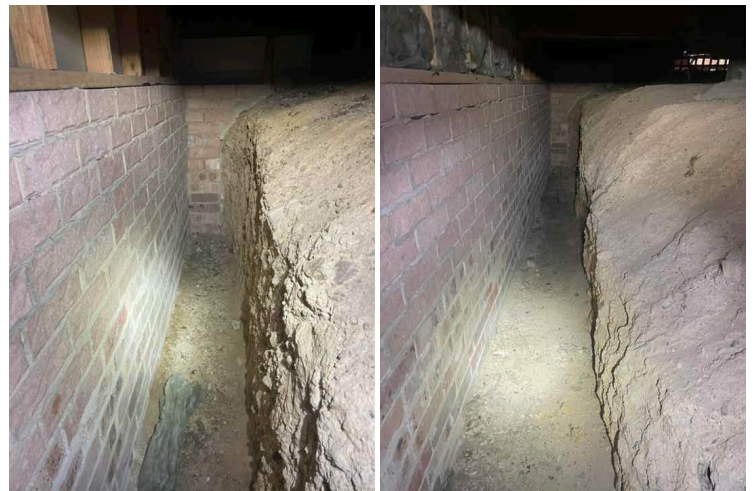
Of areas accessible and visible, the subfloor and components appeared to be in a serviceable condition.

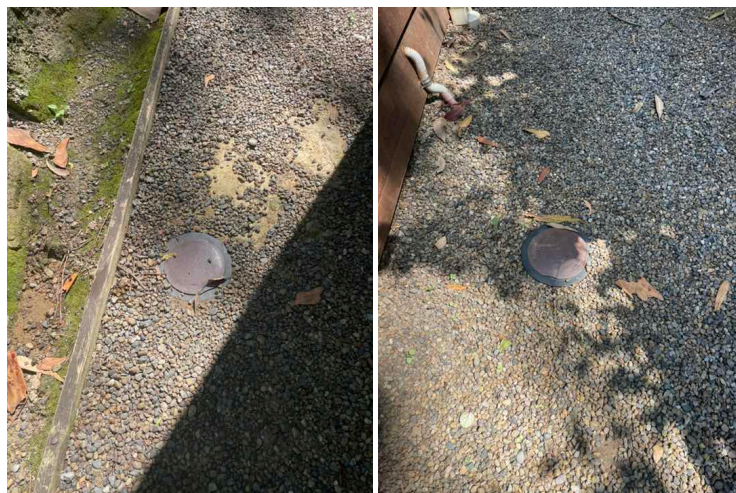
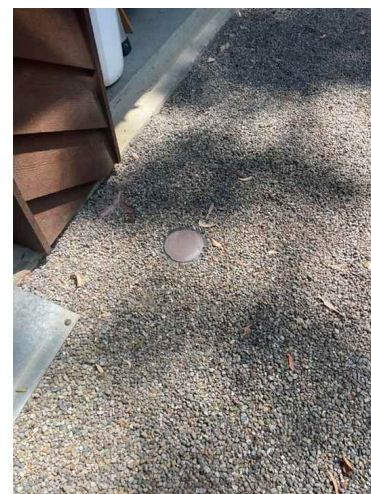
Yes, a termite Exterra monitoring system is installed.
